# **FORCON Report**

RE: Structural Investigation- Roof Collapse

Blacksburg High School Gymnasium

CLAIM #: DMF3428 FORCON CASE #: V10155

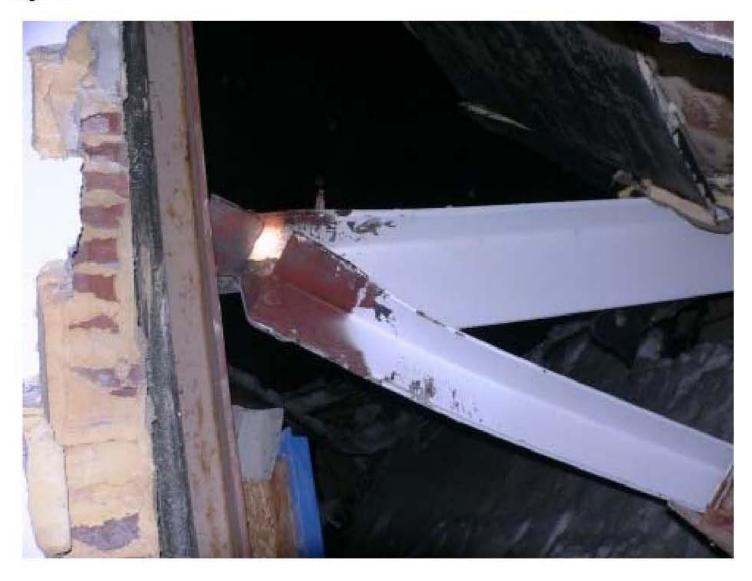
PHOTOGRAPH #8 DATE TAKEN: 2/13/2010 by others FORCON #V10155

- At the Gymnasium Floor level, Photograph # 8 shows the south end of the east roof truss. Note the top chord web has been bent upward.
  - Photograph # 9 shows the south end of the east roof truss. Note that the bottom chord has bent upward, beginning at the first web member intersection.

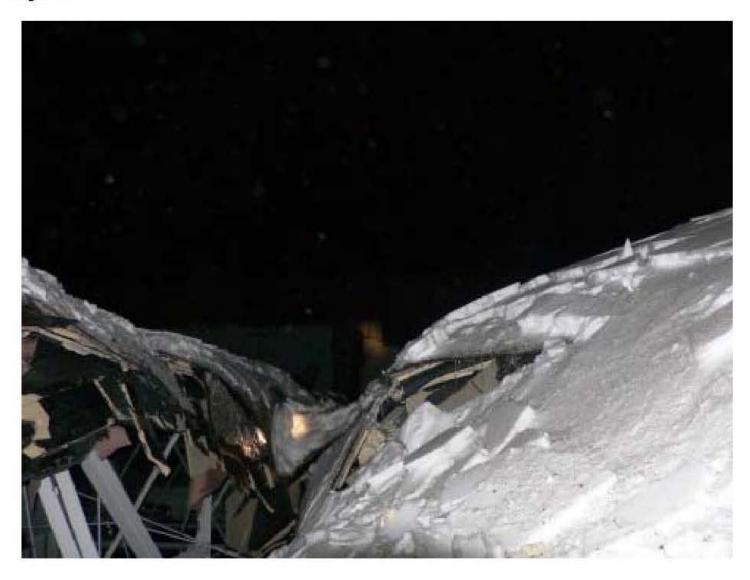
PHOTOGRAPH # 10 DATE TAKEN: 2/13/2010 by others FORCON #V10155

- Photograph # 10 shows the roof near the south end of the east roof truss. The
    roof deck split parallel with and to the right of the truss. There is approximately
    eight inches of snow on the roof.

COMMENTS: Note snow remaining on the roof.

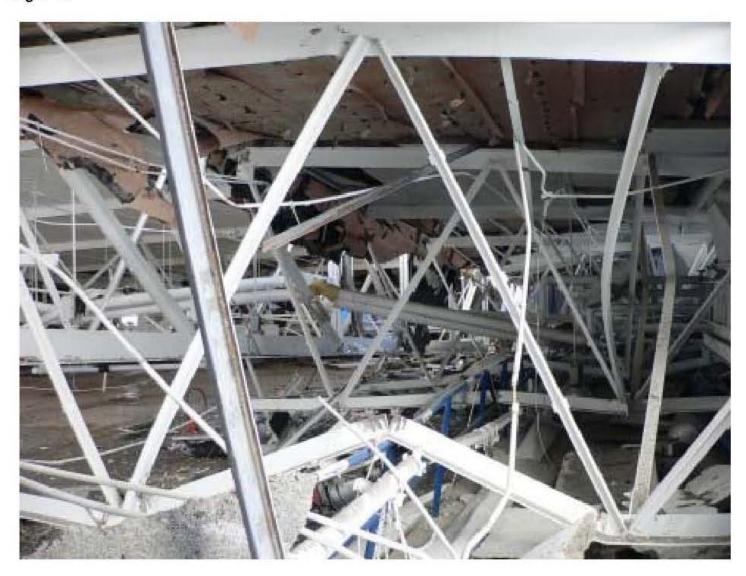
PHOTOGRAPH # 11 DATE TAKEN: 2/13/2010 by others FORCON #V10155

- Photograph # 11 shows the roof trusses to the right of the east roof truss. The truss bottom chords have broken free of the main truss.
  - Photograph # 12 shows the north end of the west roof truss. The truss bottom chords have broken free of the main truss.

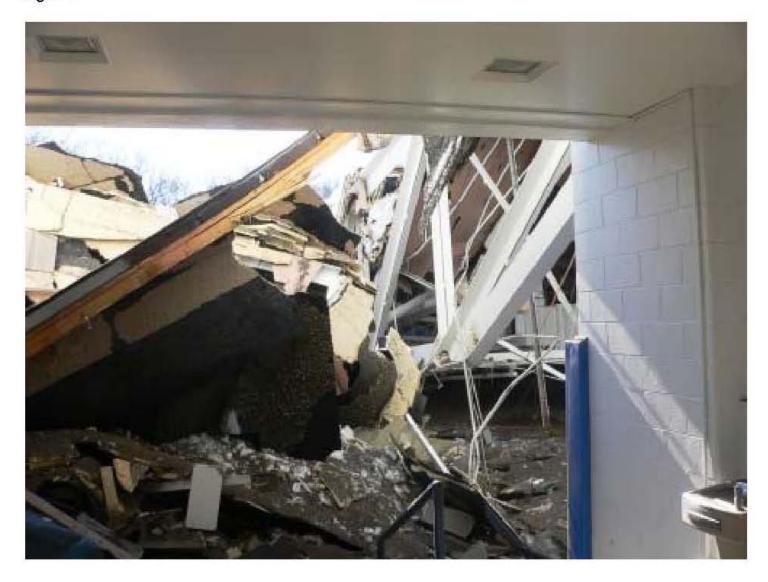
PHOTOGRAPH # 13 DATE TAKEN: 2/13/2010 by others FORCON #V10155

- Photograph # 13 shows the north end of the east roof truss. The bottom chord has bent upward.
- B. The following observations were made during our March 1 inspection:

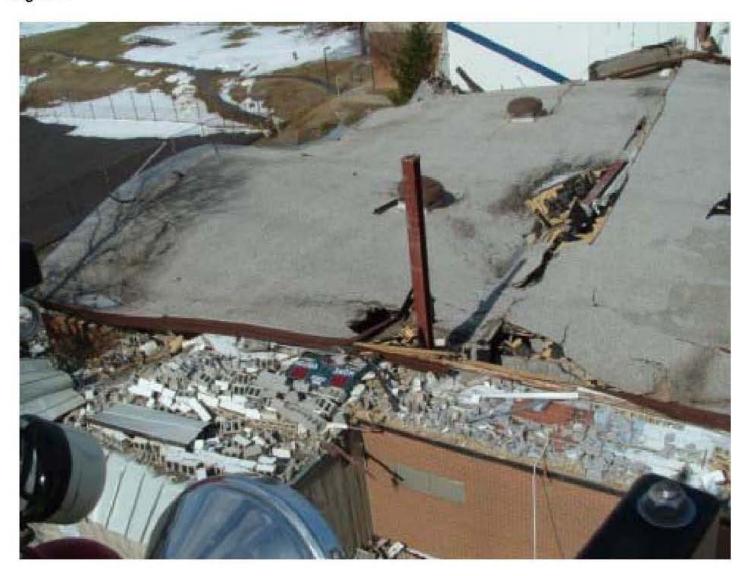
PHOTOGRAPH # 14 DATE TAKEN: 3/1/2010 FORCON #V10155

- Photograph # 14 shows the left side of the collapsed roof, as well as, the Southwest column. Note the column is straight. Also, note that the roof surface appears to be unbroken directly over the main (West) roof truss.

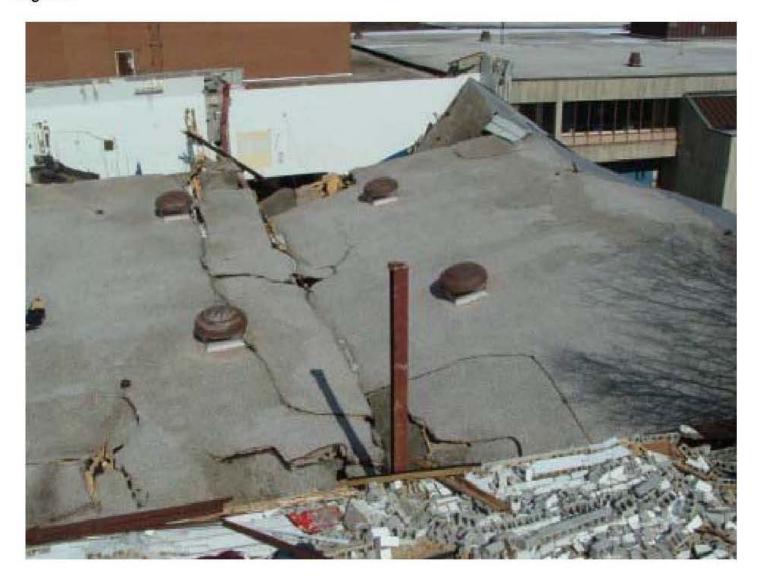
PHOTOGRAPH # 16 DATE TAKEN: 3/1/2010 FORCON #V10155

- Photograph # 15 shows the center section of the collapsed roof.
- Photograph # 16 shows the right side of the collapsed roof, as well as the Southeast roof column.

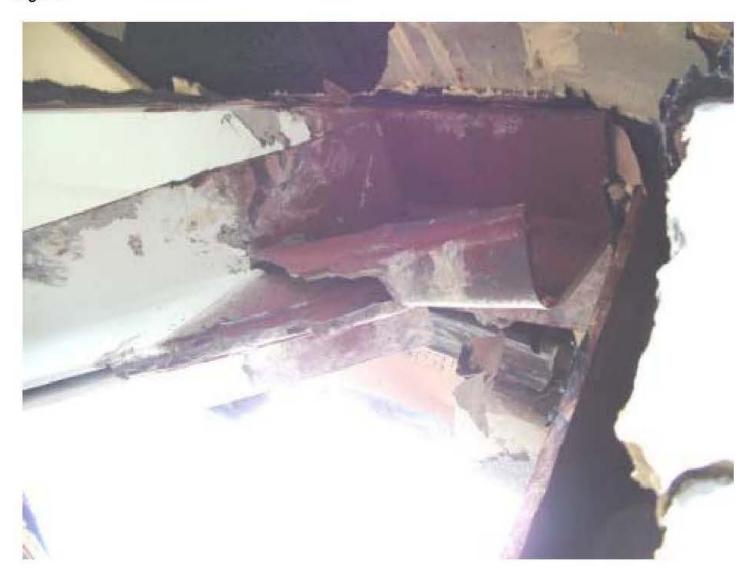
PHOTOGRAPH # 23 DATE TAKEN: 3/1/2010 FORCON #V10155

- On the Gymnasium floor level, Photographs # 22, # 23, and # 24 show the South end of the West main truss. The web of the truss seat has several horizontal tears. The lowest tear is below the horizontal weld that originally joined the upper and lower halves of the truss seats. The masonry surrounding the Southwest column has been broken away.

COMMENTS: Note bent/torn web of truss seat.

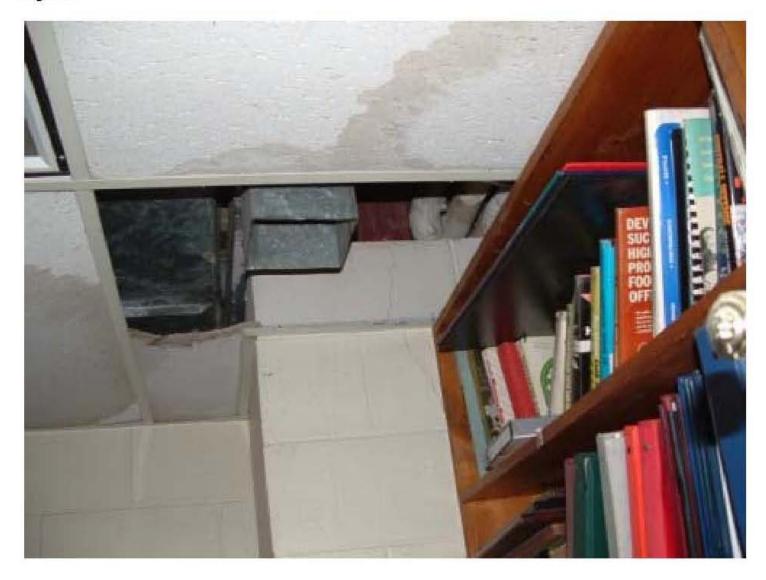
PHOTOGRAPH # 25 DATE TAKEN: 3/1/2010 FORCON #V10155

- On the Ground floor, Photograph # 25 shows the masonry pilaster that surrounds the lower portion of the Southwest column.
- Photograph # 26 shows top of the Northwest and Northeast columns. Both columns are bent at the location where the truss bottom chord connected, so that the top of the columns are bent toward the South.

COMMENTS: Note vertical crack.

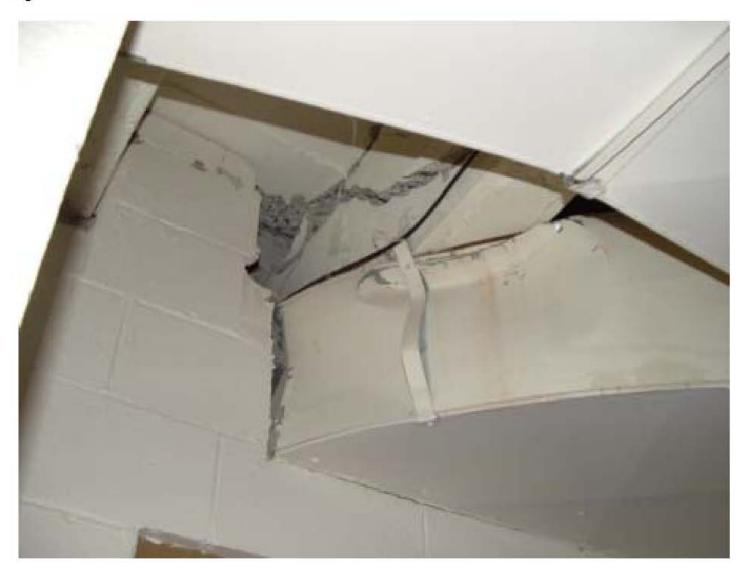
PHOTOGRAPH # 45 DATE TAKEN: 3/1/2010 FORCON #V10155

COMMENTS: Located below first truss panel point 12 feet in front of Southeast column.

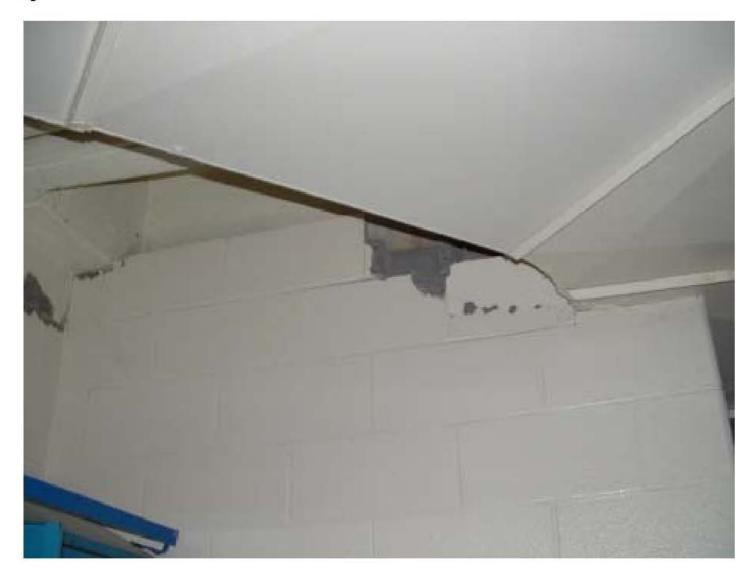
PHOTOGRAPH # 46 DATE TAKEN: 3/1/2010 FORCON #V10155

OF SUBJECT: View of Damage to CMU Load-bearing Wall

COMMENTS: Located below first truss panel point 12 feet in front of Southeast column.

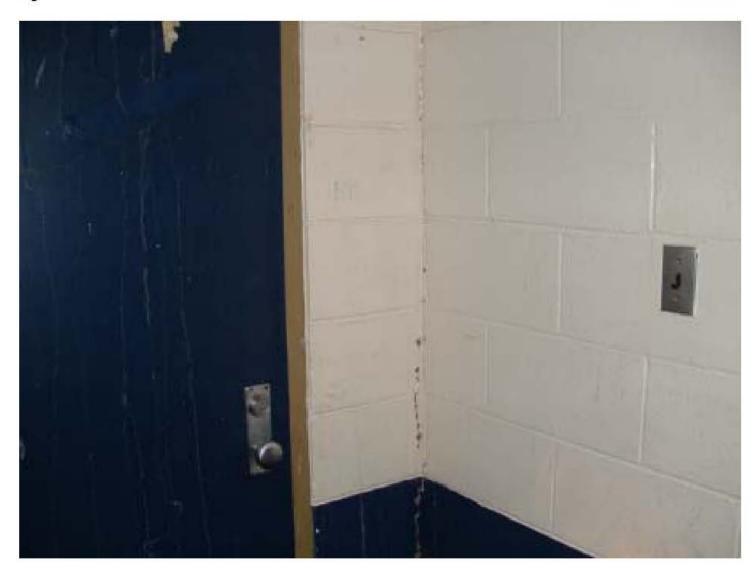
PHOTOGRAPH # 47 DATE TAKEN: 3/1/2010 FORCON #V10155

OF SUBJECT: View of Damage to CMU Load-bearing Wall

COMMENTS: Located below first truss panel point 12 feet in front of Southeast column.

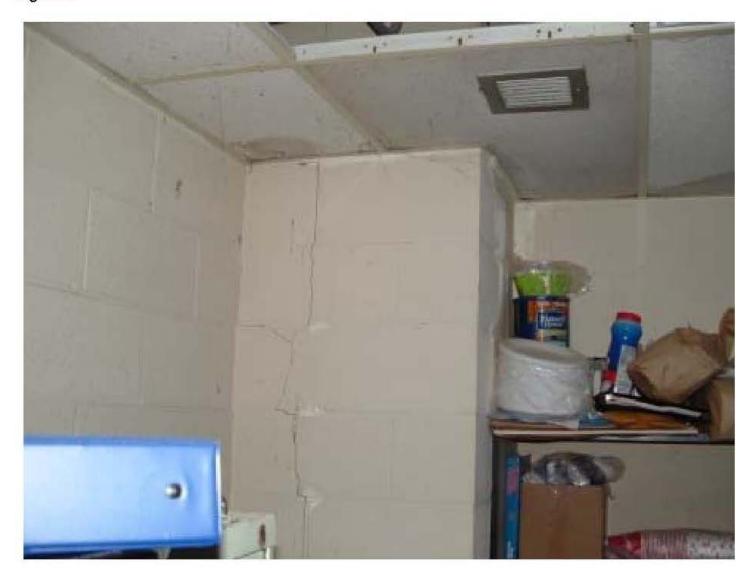
PHOTOGRAPH # 48 DATE TAKEN: 3/1/2010 FORCON #V10155

- On the Gymnasium Floor Level, Photographs # 42 and # 43 show South end of the East main roof truss. The bottom chord is bent upward from the first truss panel point. The first truss panel point is located approximately 12 feet from the Southeast column. The first vertical web member is bent. Directly below this panel point, there is a hole punched through the concrete Gymnasium floor (Photographs # 44 and # 45). On the Ground Floor, at the JV Team Room door, Photographs # 46 and # 47 show damage to the CMU bearing wall below. Photograph # 48 shows cracking in the CMU pilaster surrounding the Southeast column.

COMMENTS: Note vertical crack.

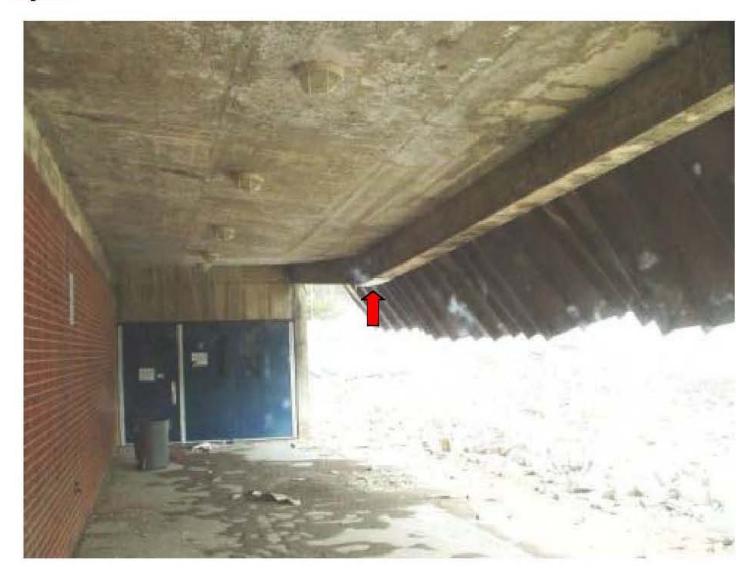
PHOTOGRAPH # 50 DATE TAKEN: 3/1/2010 FORCON #V10155

- On the Ground Level, at the front of the building, a concrete canopy extends between masonry stair towers (Photograph # 49). The canopy extends 48 feet across and is 10 feet 6 inches wide. Photograph # 50 shows that the 12 inch wide by 40 inch deep beam that supports the front edge of the canopy has broken.

COMMENTS: Red arrow denotes break in the beam.

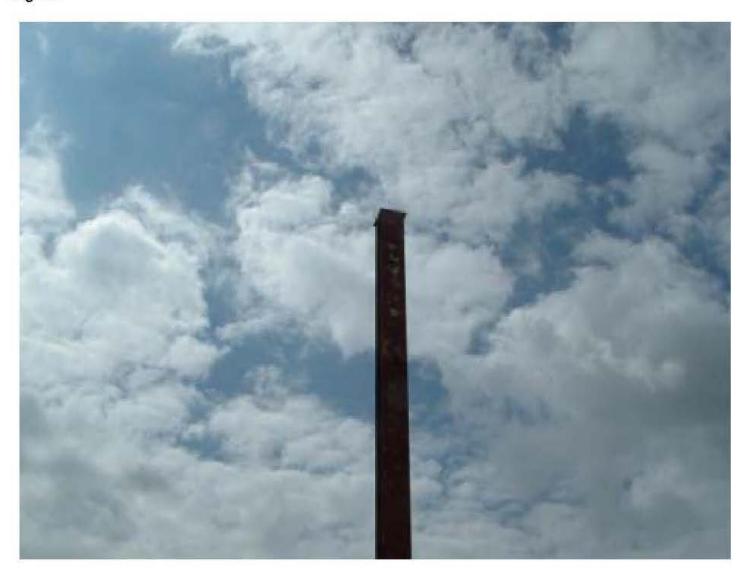
PHOTOGRAPH # 73 DATE TAKEN: 5/19/2010 FORCON #V10155

- The Southwest column is twisted and out of plumb (Photographs # 73 and #74). During demolition, the contractor hit the column with his construction equipment, and damaged the column.

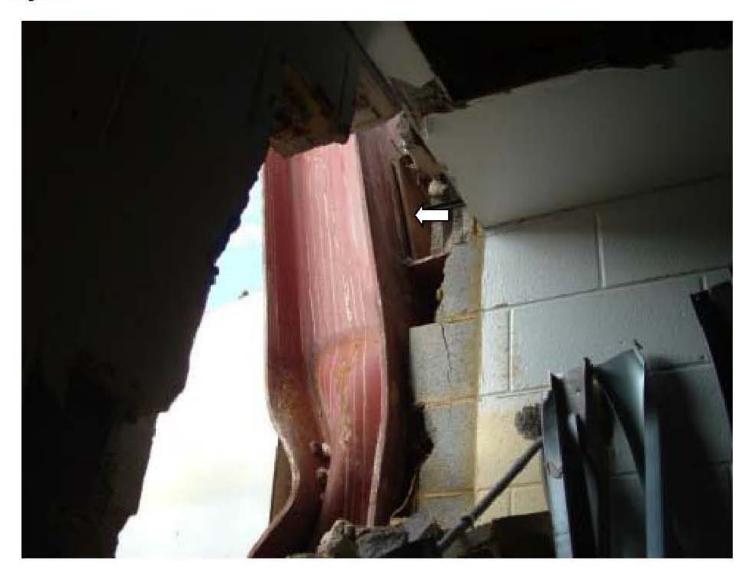
PHOTOGRAPH # 77 DATE TAKEN: 5/19/2010 FORCON #V10155

- Photograph # 77 shows the Northwest column bent outward with steel beam attached at the mezzanine roof level, shifting the beam outward. See Photograph # 78. Photograph # 79 shows water damage to the press box roof. Photograph # 80 shows the press box area with walls and roof removed.

COMMENTS: White arrow denotes beam end.

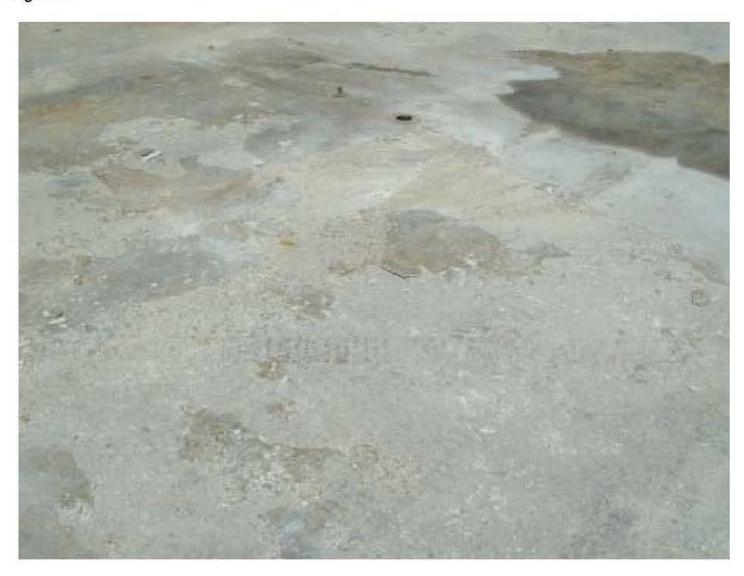
PHOTOGRAPH # 81 DATE TAKEN: 5/19/2010 FORCON #V10155

- The main portion of the Gymnasium Floor has numerous areas where the surface has delaminated to a depth of 1/2 inch or less (Photograph # 81). This condition occurs on approximately 20 percent of the slab at this level.

- 3. Concrete spalling on the main level. This can be repaired using a latex-modified concrete topping.
- 4. Concrete cracking in the bottom of the concrete joist and turned-down beam (Photograph # 96). The CMU walls adjacent to this location are also cracked (Photograph # 95). The repair involves installing a steel beam with plate beneath the concrete turned-down beam that spans from each CMU Load-bearing wall, then firerating the beam by installing fire code gypsum wall board, wrapping it.

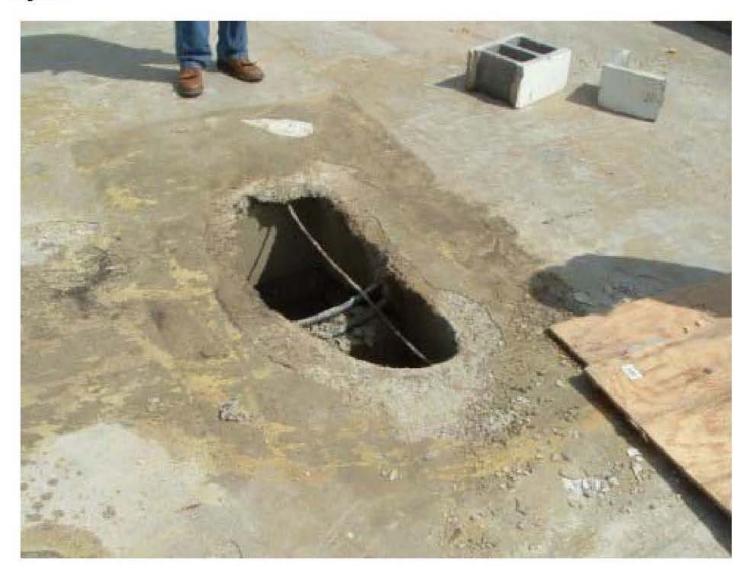
PHOTOGRAPH # 84 DATE TAKEN: 5/19/2010 FORCON #V10155

- Photograph # 84 shows the hole that was punched through the slab and joists by the bottom chord and vertical web of the East main truss (directly below Photographs # 42 and # 43). Photograph # 85 shows the joist broken away from the concrete turndown beam- there is no reinforcement visible in the turndown beam. Photograph # 86 shows the underside of this area- there has been no movement in the crack monitor.

1. Two foot diameter hole located 12 feet from the Southeast column. The corrective repair at this location involves the installation of temporary false work, then removing the slab

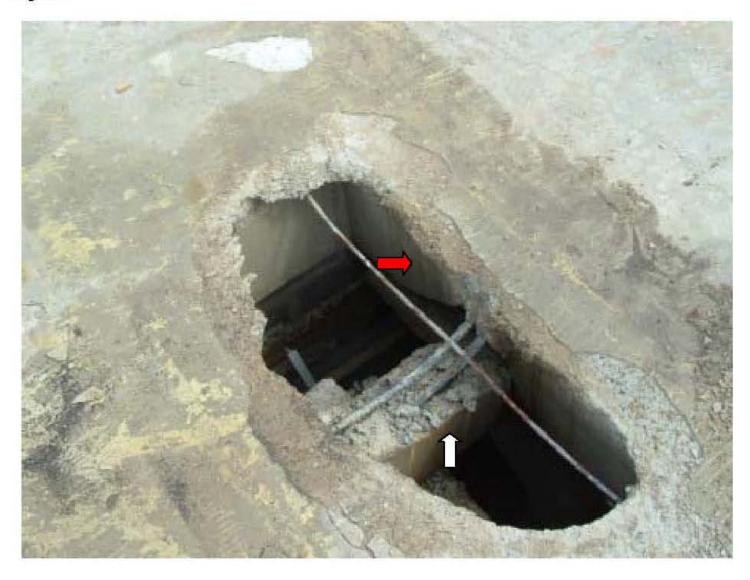
PHOTOGRAPH # 85 DATE TAKEN: 5/19/2010 FORCON #V10155

COMMENTS: White arrow denotes concrete floor joist. Red arrow denotes broken turned-

down concrete beam.

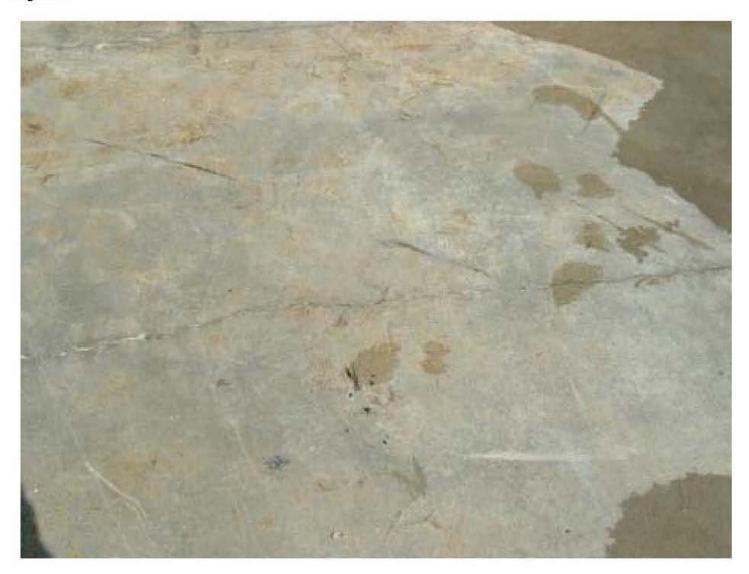
PHOTOGRAPH # 87 DATE TAKEN: 5/19/2010 FORCON #V10155

- On the right raised area, there are two hairline cracks in the slab that extend from the left to the right sides (Photographs #87 and # 88). They are located approximately 35 and 70 feet from the front of the building.

OF SUBJECT: View of Cracks in Right Raised Gymnasium Floor Area

- 5. Cracking of concrete slab and pan joist at various locations. The repair of these involves routing out the cracks, then installing a good quality, siliconized caulk.

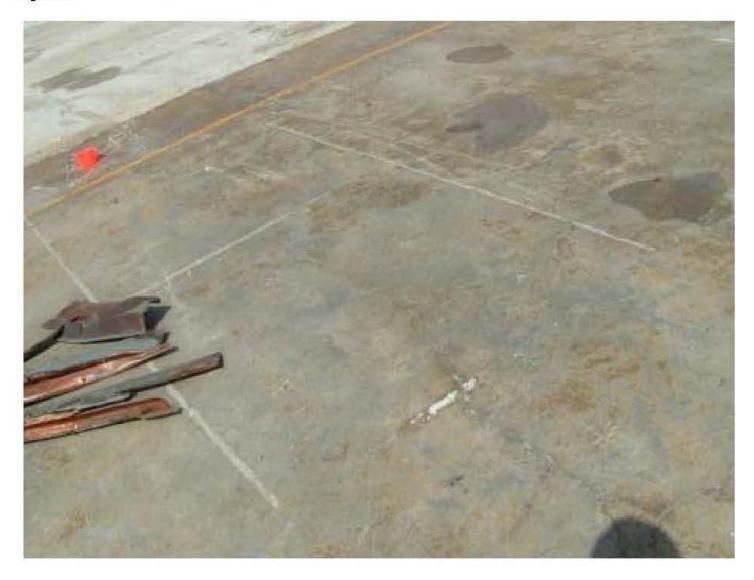
PHOTOGRAPH # 88 DATE TAKEN: 5/19/2010 FORCON #V10155

OF SUBJECT: View of Cracks in Right Raised Gymnasium Floor Area

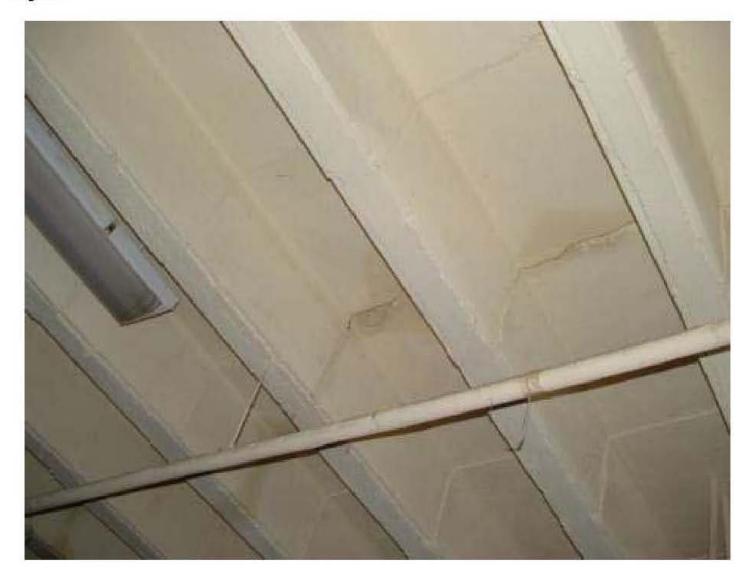
PHOTOGRAPH # 89 DATE TAKEN: 5/19/2010 FORCON #V 10155

- On the left raised area, there are two hairline cracks in the slab that extend from the left to the right sides, located approximately 35 and 70 feet from the front of the building. Photographs # 89, # 90, and # 91 show the crack located at 35 feet, viewed from the underside (Ground Level Ceiling) - the crack extends through the joists, with no reinforcement visible. Photographs # 92 and # 93 show the crack located at 70 feet.

OF SUBJECT: View of Cracks in Left Raised Gymnasium Floor Area

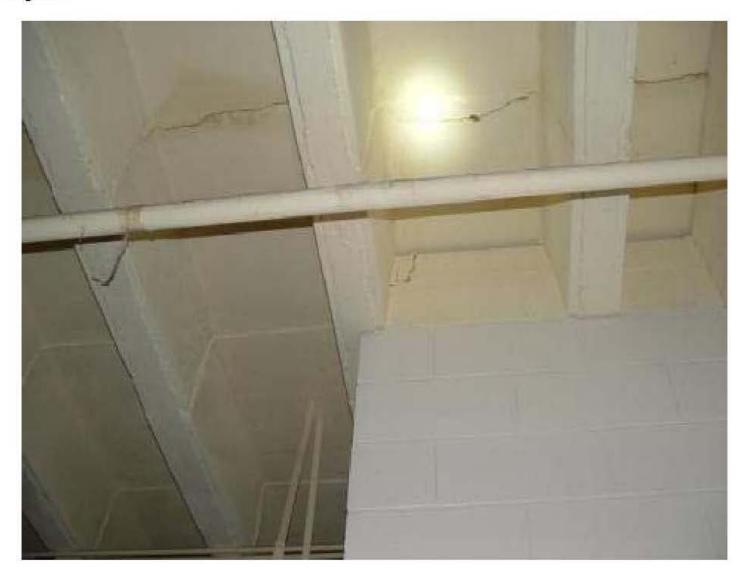
PHOTOGRAPH # 90 DATE TAKEN: 5/19/2010 FORCON #V10155

OF SUBJECT: View of Cracks in Left Raised Gymnasium Floor Area

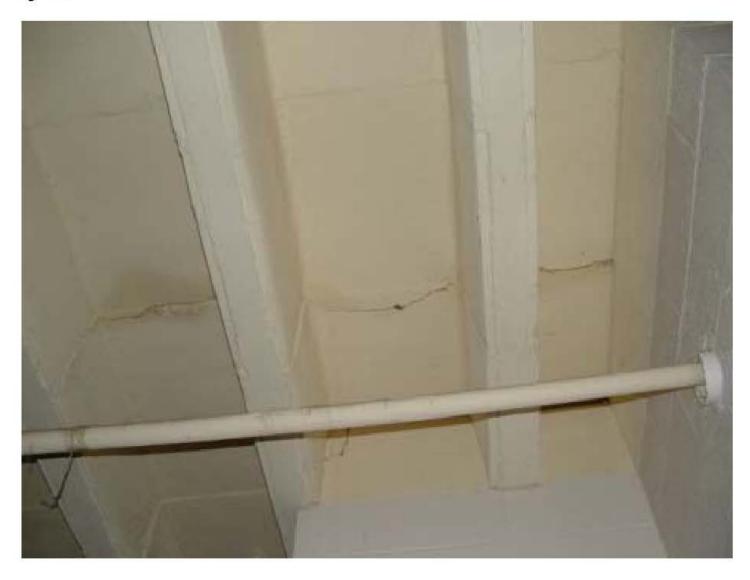
PHOTOGRAPH # 91 DATE TAKEN: 5/19/2010 FORCON #V10155

OF SUBJECT: View of Cracks in Left Raised Gymnasium Floor Area

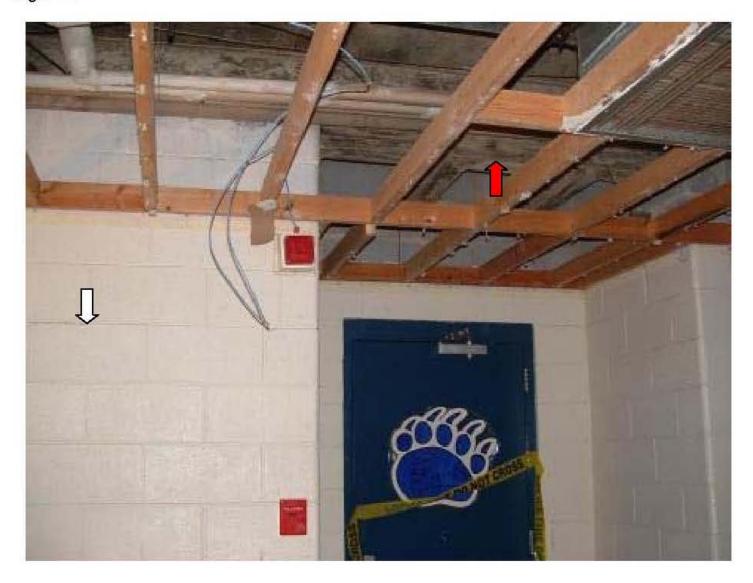
PHOTOGRAPH # 95 DATE TAKEN: 5/19/2010 FORCON #V10155

- On the right side of the West corridor, approximately 20 feet from the front of the building, Photographs # 95 and # 96 show a crack in the CMU wall, concrete joist, and concrete beam turndown (similar location to Photograph # 84).

OF SUBJECT: View of Cracks in CMU Load-bearing Wall Right Side at Ground Floor Level

COMMENTS: White arrow denotes cracks. Red arrow denotes bottom of concrete turned -

down beam...

- 6. Cracking of the Ground Level CMU Load-bearing walls. This can be repaired by routing out the joints and re-pointing with mortar, then repainting the area.

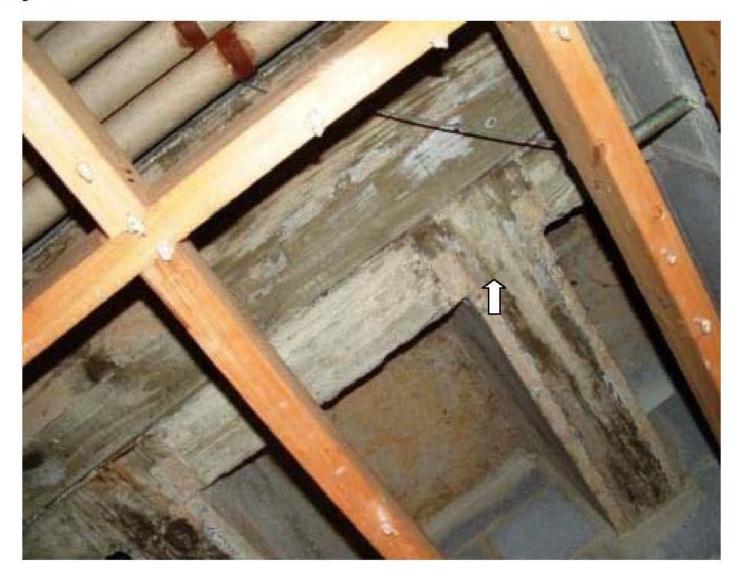
PHOTOGRAPH # 96 DATE TAKEN: 5/19/2010 FORCON #V 10155

OF SUBJECT: View of Cracks in Concrete above Right Side of West Corridor at Ground

COMMENTS: White arrow denotes cracks. Red arrow denotes bottom of concrete turned -
