# **FORCON Report**

RE: Structural Investigation- Roof Collapse

Blacksburg High School Gymnasium

CLAIM #: DMF3428 FORCON CASE #: V10155

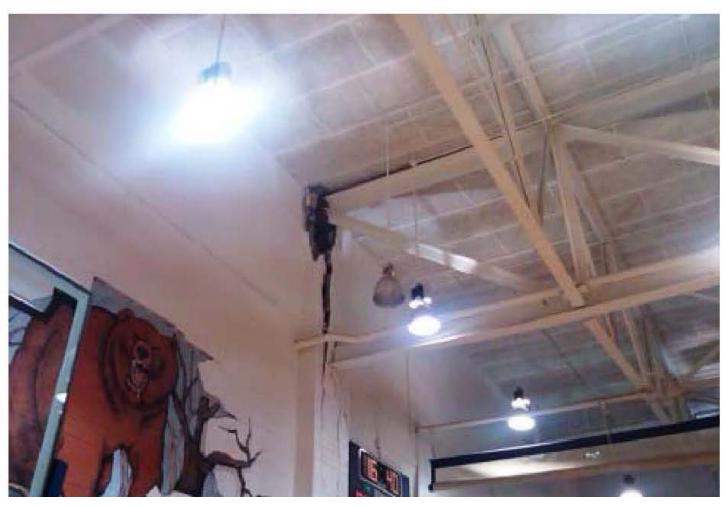
PHOTOGRAPH # 4 DATE TAKEN: 2/13/2010 by others FORCON #V10155

COMMENTS: Note CMU has fallen away and is cracked vertically.

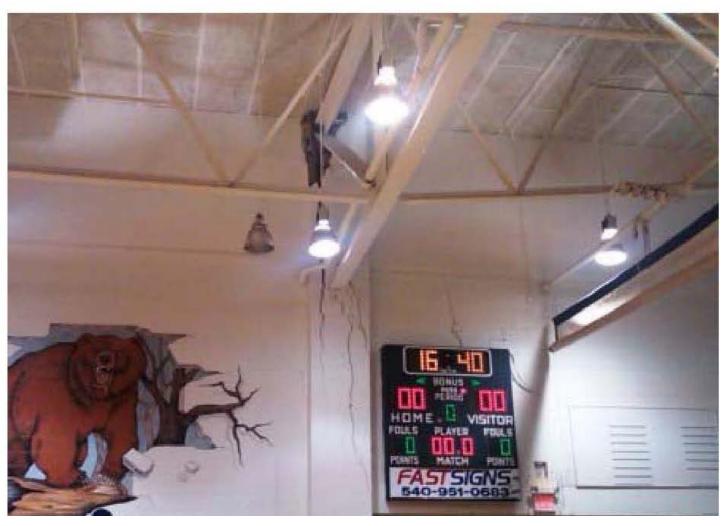
PHOTOGRAPH # 5 DATE TAKEN: 2/13/2010 by others FORCON #V10155

COMMENTS: Note top of truss has "rolled" to the left.

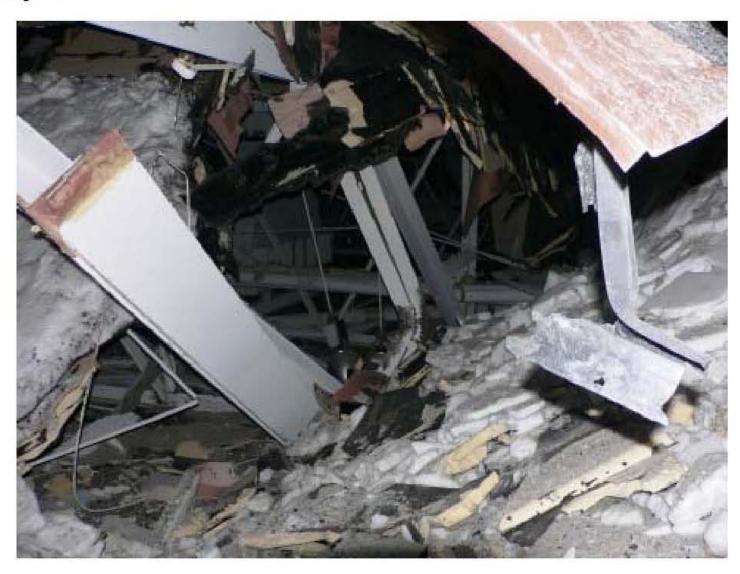
PHOTOGRAPH #9 DATE TAKEN: 2/13/2010 by others FORCON #V10155

- At the Gymnasium Floor level, Photograph # 8 shows the south end of the east roof truss. Note the top chord web has been bent upward.
  - Photograph # 9 shows the south end of the east roof truss. Note that the bottom chord has bent upward, beginning at the first web member intersection.

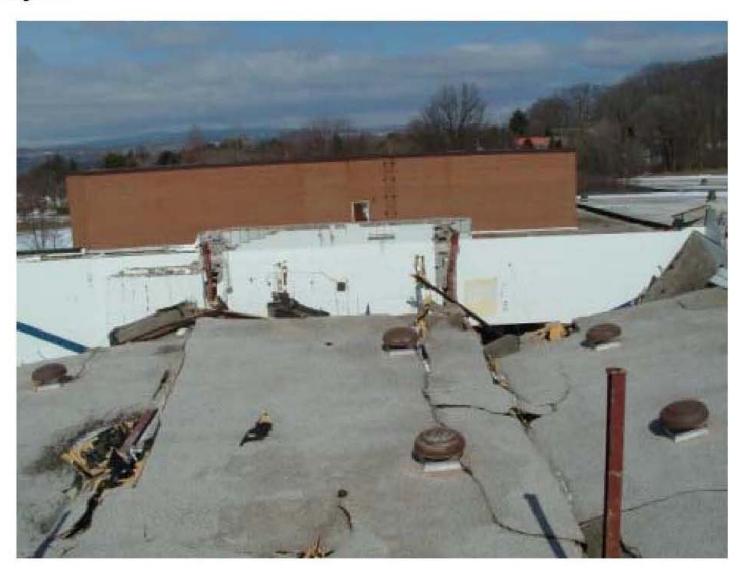
PHOTOGRAPH # 15 DATE TAKEN: 3/1/2010 FORCON #V10155

- Photograph # 15 shows the center section of the collapsed roof.
- Photograph # 16 shows the right side of the collapsed roof, as well as the Southeast roof column.

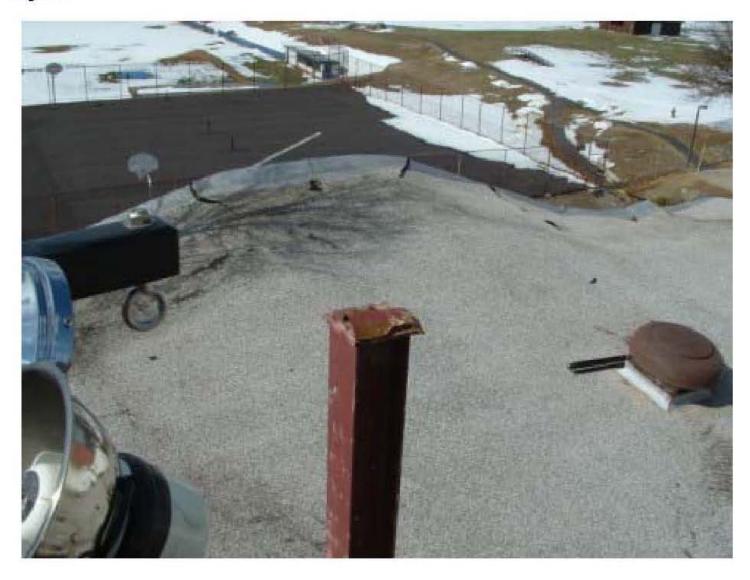
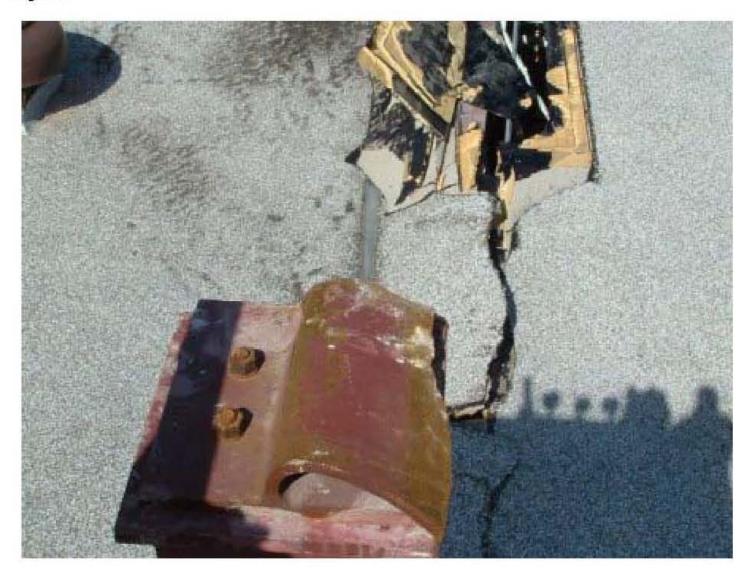
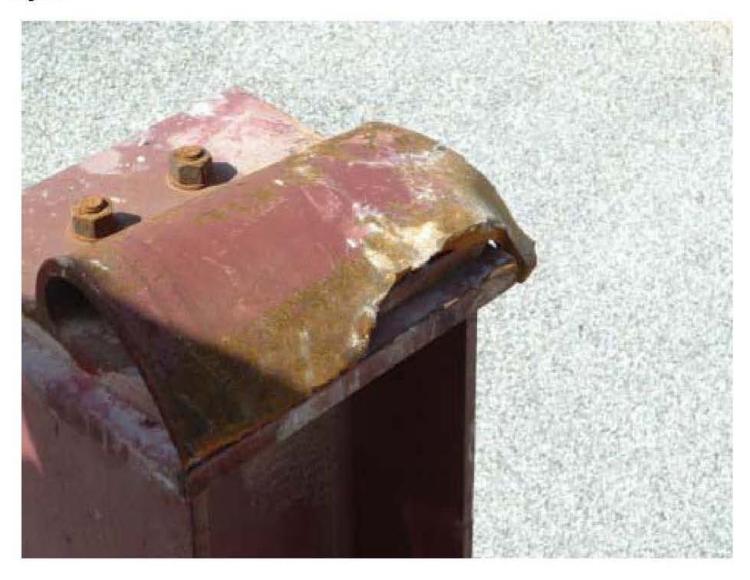
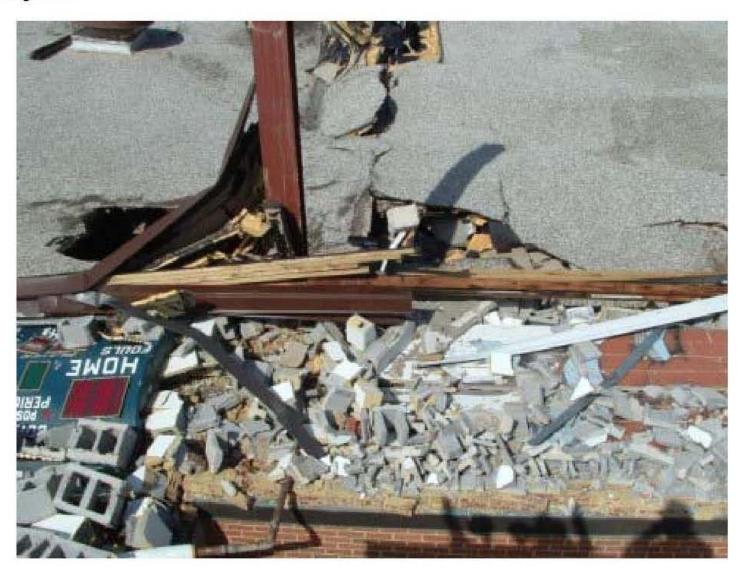
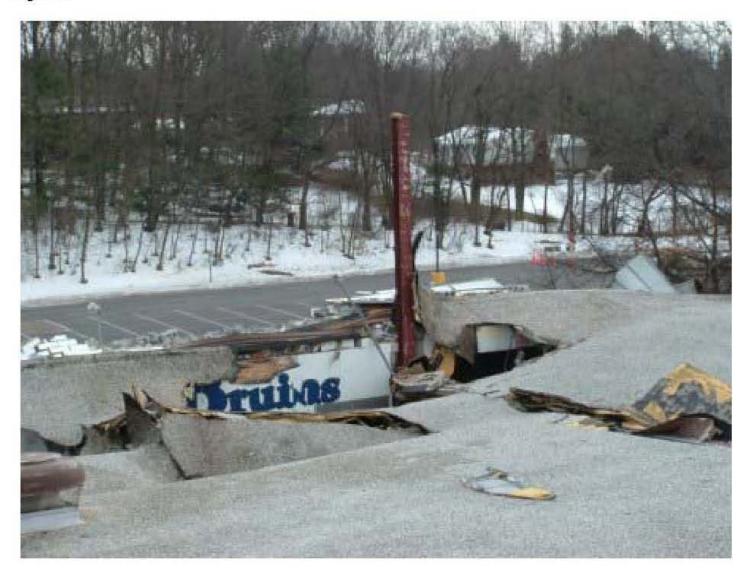
- Photographs # 17, # 18, # 19, # 20, and #21 show the top of the Southwest column. The bottom portion of the truss seat remains attached to the top of the column. The web is bent to the right, with several notches.

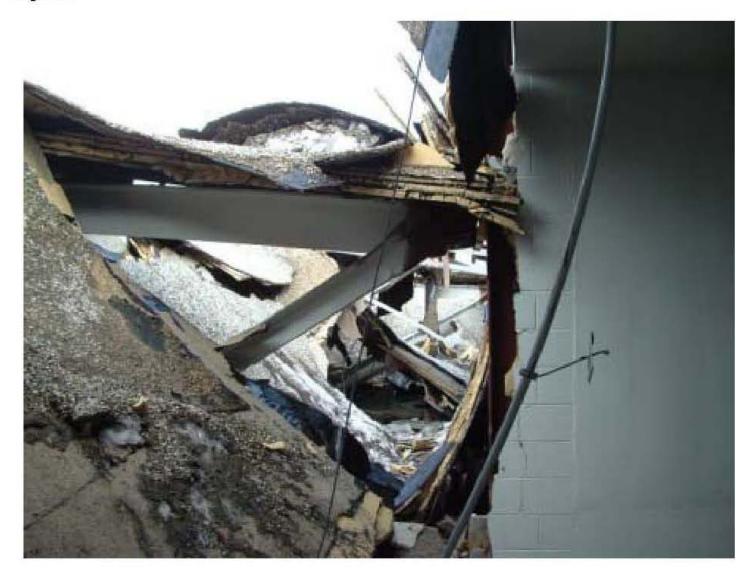
PHOTOGRAPH # 22 DATE TAKEN: 3/1/2010 FORCON #V10155

- On the Gymnasium floor level, Photographs # 22, # 23, and # 24 show the South end of the West main truss. The web of the truss seat has several horizontal tears. The lowest tear is below the horizontal weld that originally joined the upper and lower halves of the truss seats. The masonry surrounding the Southwest column has been broken away.

COMMENTS: Note bent/torn web of truss seat.

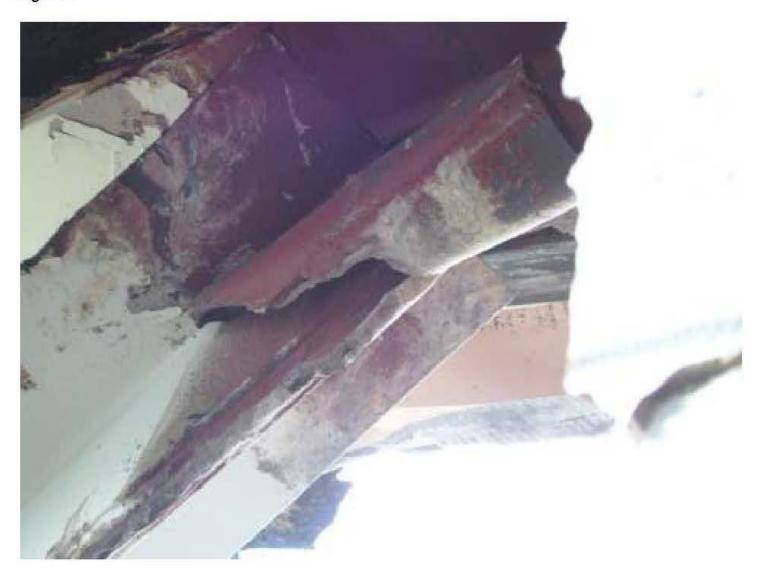
PHOTOGRAPH # 24 DATE TAKEN: 3/1/2010 FORCON #V10155

COMMENTS: Note vertical crack.

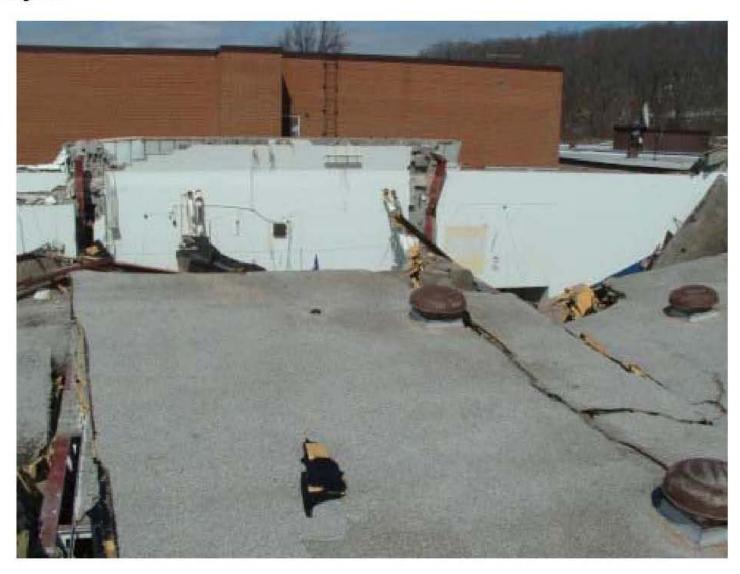
PHOTOGRAPH # 26 DATE TAKEN: 3/1/2010 FORCON #V10155

- On the Ground floor, Photograph # 25 shows the masonry pilaster that surrounds the lower portion of the Southwest column.
- Photograph # 26 shows top of the Northwest and Northeast columns. Both columns are bent at the location where the truss bottom chord connected, so that the top of the columns are bent toward the South.

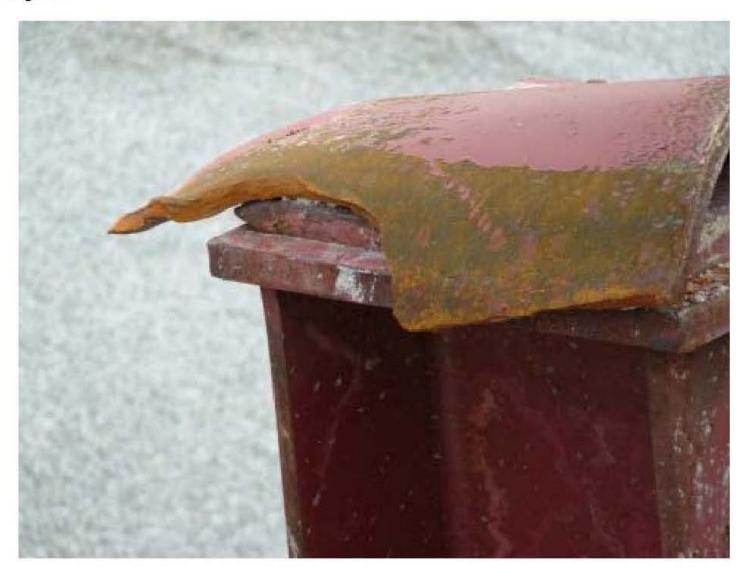
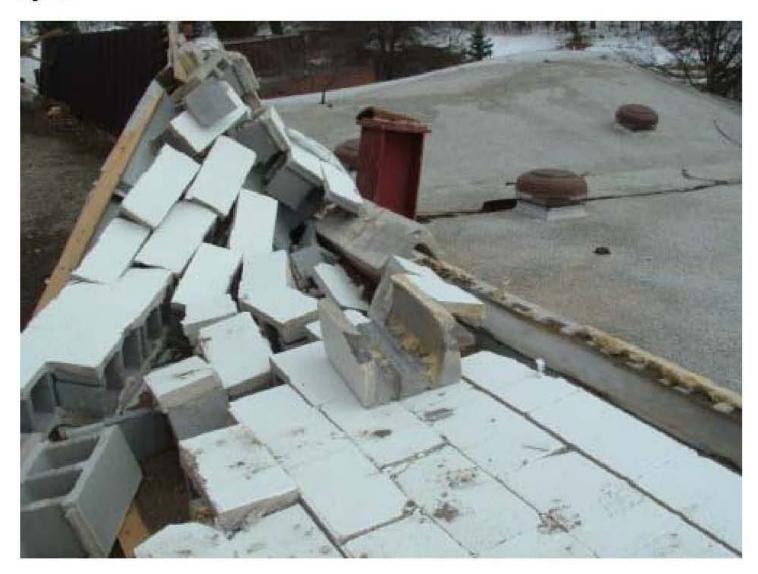
- Photographs # 27 and # 28 show the top of the Northwest column. The truss seat remains attached to the top of the column and is bent to the right. The CMU wall that extended to the Gymnasium roof is also shown- there is no reinforcement visible. This CMU wall fell away from the Gymnasium.

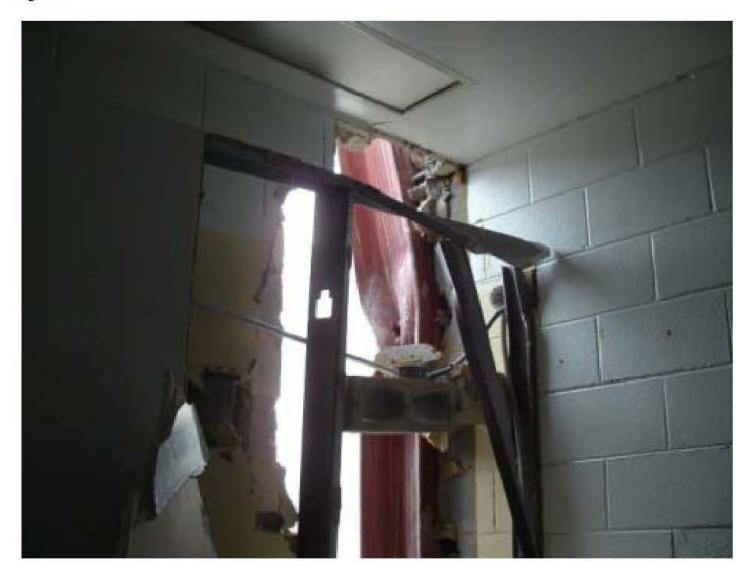
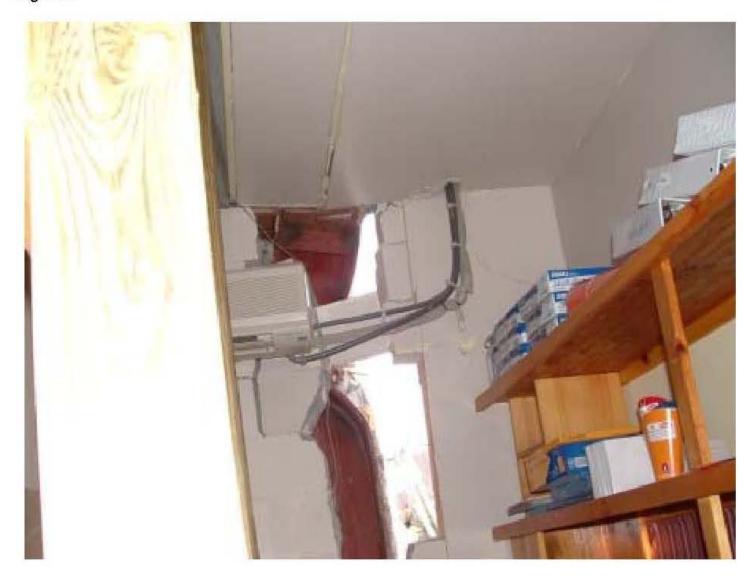
- On the Mezzanine level, Photographs # 29 and # 30 show a bend in the Northwest column. Photograph # 31 shows shoring posts added below the roof beam because the CMU wall was pulled outward by the column movement.

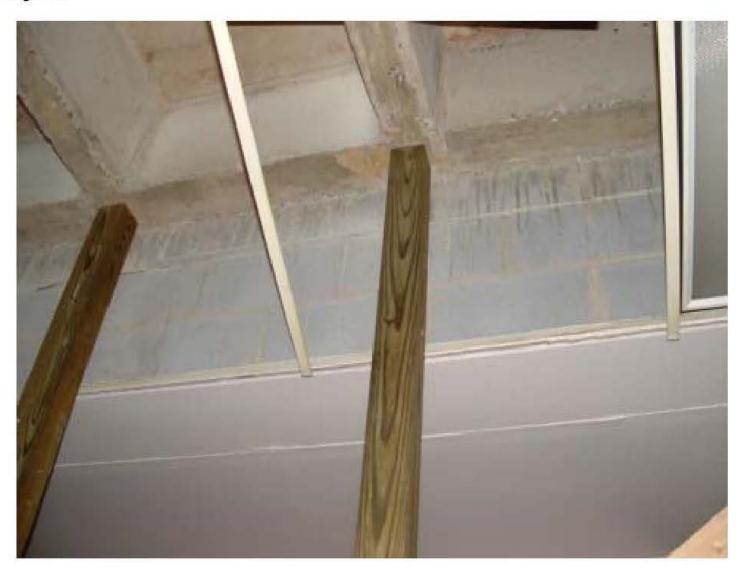
PHOTOGRAPH # 31 DATE TAKEN: 3/1/2010 FORCON #V10155

COMMENTS: Note masonry wall is pulled out from under the concrete beam above.

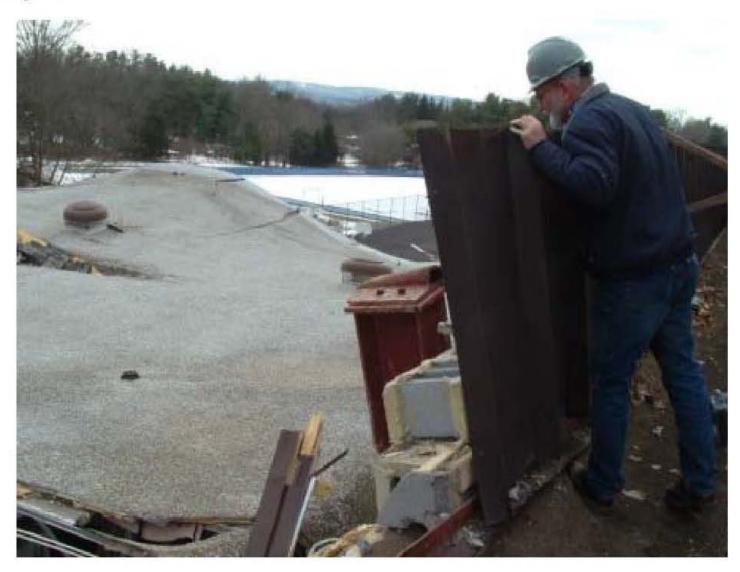
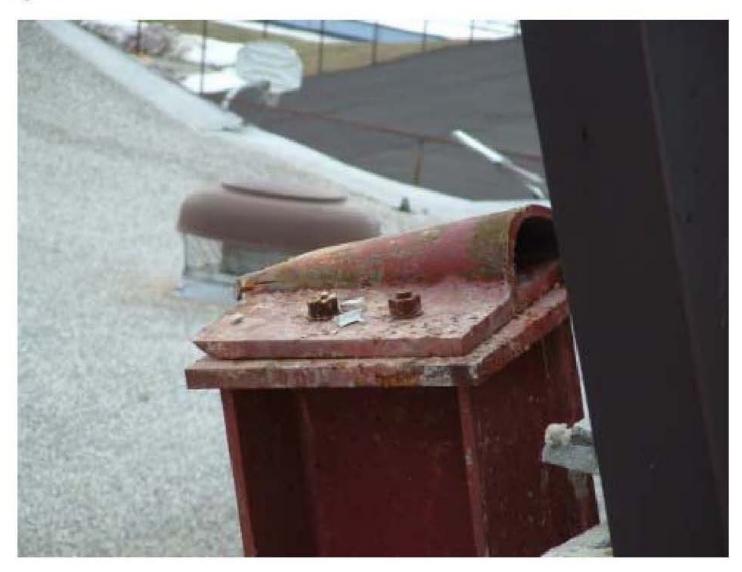
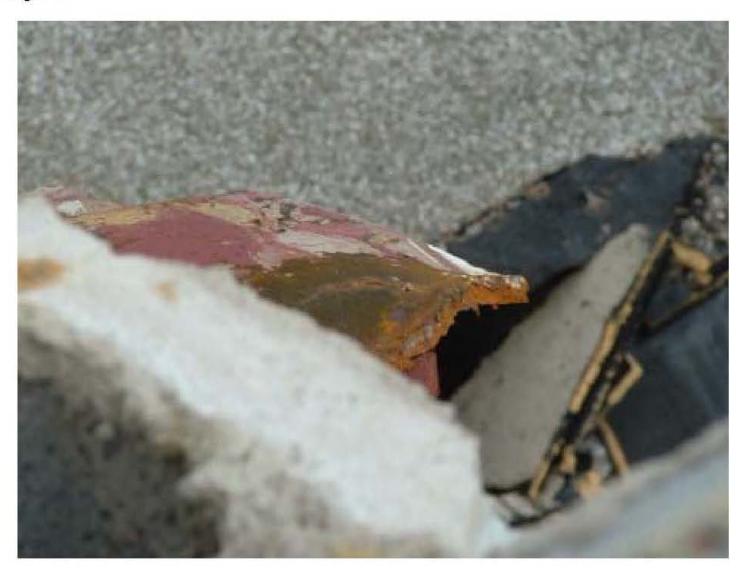
- Photographs # 32, # 33, and # 34 show the top of the Northeast column. The truss seat remains attached to the top of the column, and is bent to the left. The CMU wall that extended to the Gymnasium roof fell into the Gymnasium.

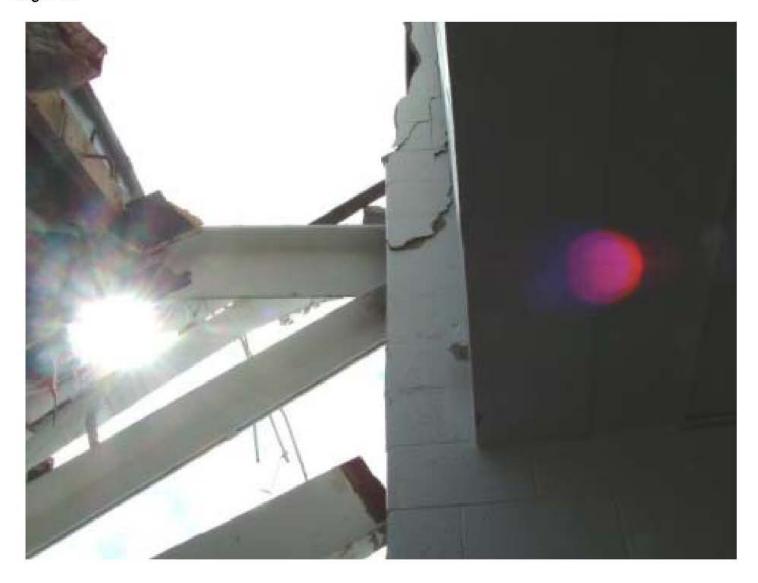
PHOTOGRAPH # 35

- On the Gymnasium floor Level, Photographs # 35 and # 36 shows the North end of the East main truss. The top chord is jammed against the column, and holding the end of the truss above the Gymnasium floor.

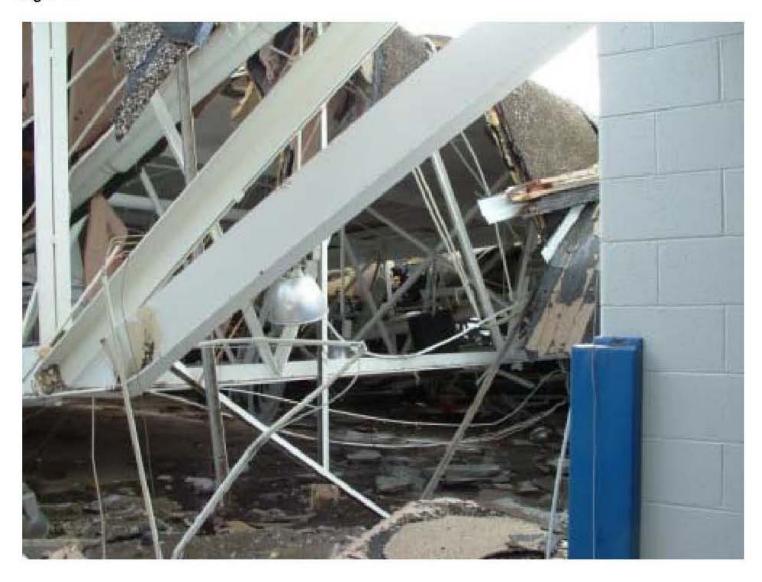
PHOTOGRAPH # 36 DATE TAKEN: 3/1/2010 FORCON #V10155

COMMENTS: Note truss bottom chord is suspended above floor.

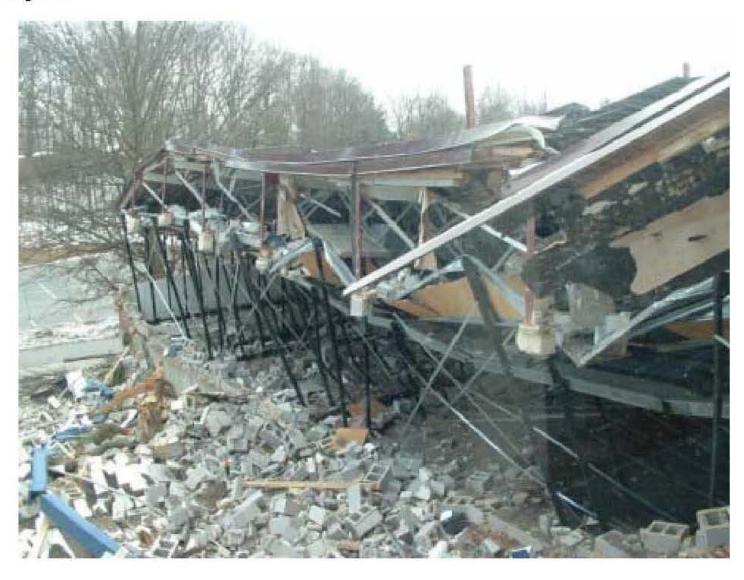
PHOTOGRAPH # 37 DATE TAKEN: 3/1/2010 FORCON #V10155

- Photograph # 37 shows the right side of the Gymnasium. The roof trusses are resting on the bleachers.
- Photographs # 38, # 39, # 40 show the upper portion of the Southeast Column. The bottom of the truss seat measures 12 inches wide by 12 inches deep. The web is bent to the left. Photograph # 41 shows the roof debris at this column.

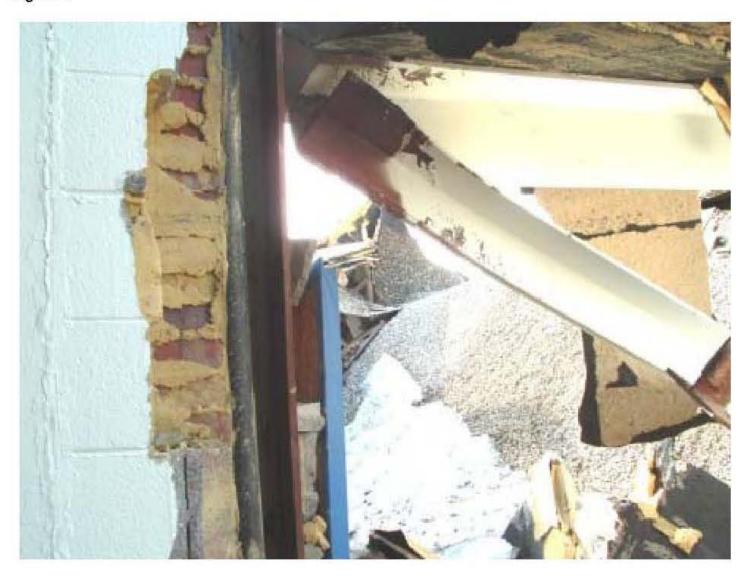
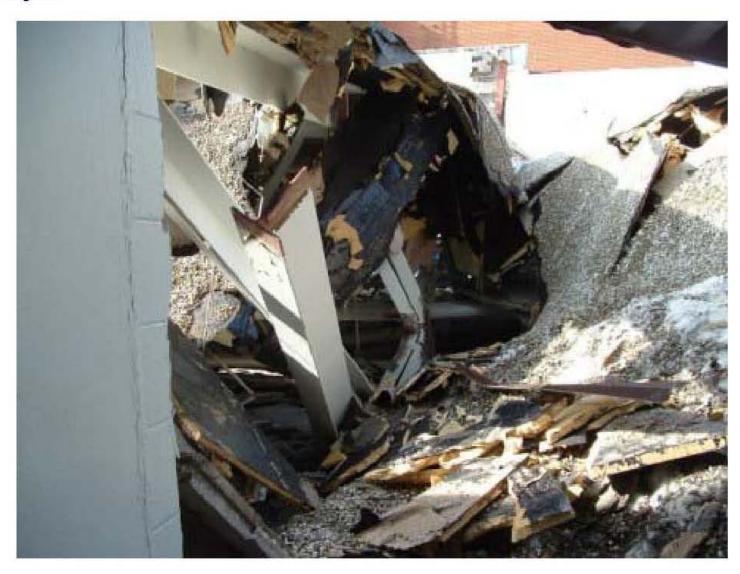
- On the Gymnasium Floor Level, Photographs # 42 and # 43 show South end of the East main roof truss. The bottom chord is bent upward from the first truss panel point. The first truss panel point is located approximately 12 feet from the Southeast column. The first vertical web member is bent. Directly below this panel point, there is a hole punched through the concrete Gymnasium floor (Photographs # 44 and # 45). On the Ground Floor, at the JV Team Room door, Photographs # 46 and # 47 show damage to the CMU bearing wall below. Photograph # 48 shows cracking in the CMU pilaster surrounding the Southeast column.

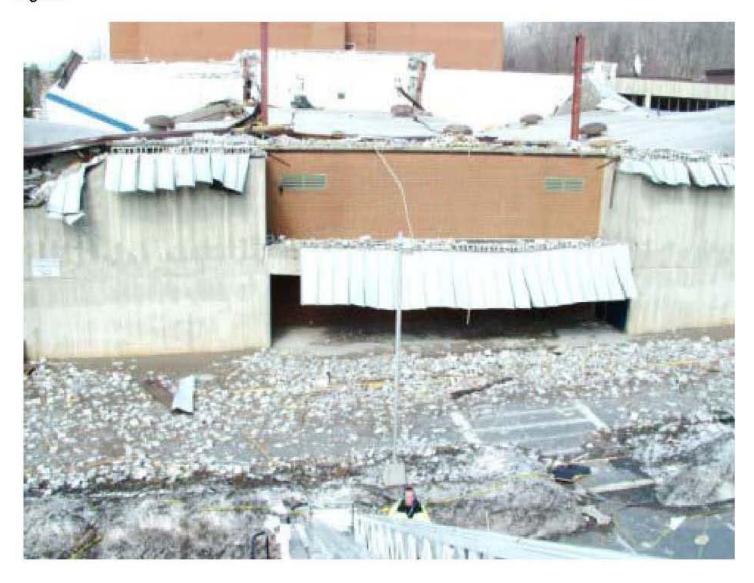
PHOTOGRAPH # 49 DATE TAKEN: 3/1/2010 FORCON #V10155

- On the Ground Level, at the front of the building, a concrete canopy extends between masonry stair towers (Photograph # 49). The canopy extends 48 feet across and is 10 feet 6 inches wide. Photograph # 50 shows that the 12 inch wide by 40 inch deep beam that supports the front edge of the canopy has broken.

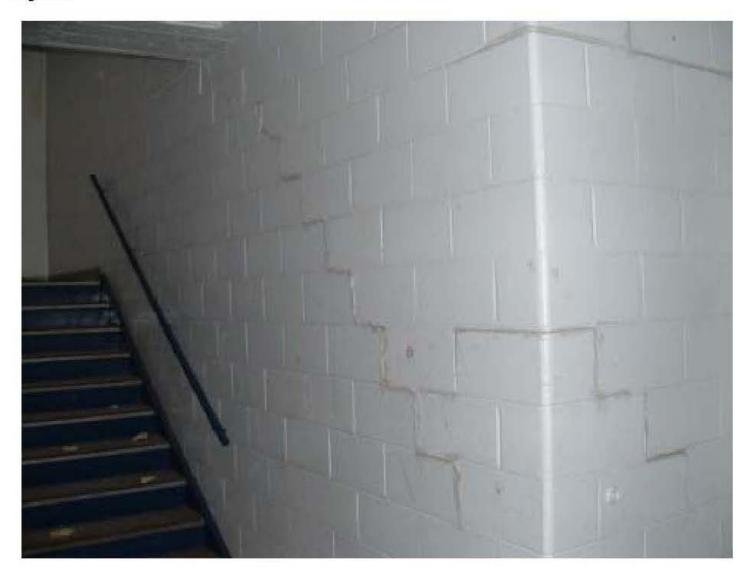
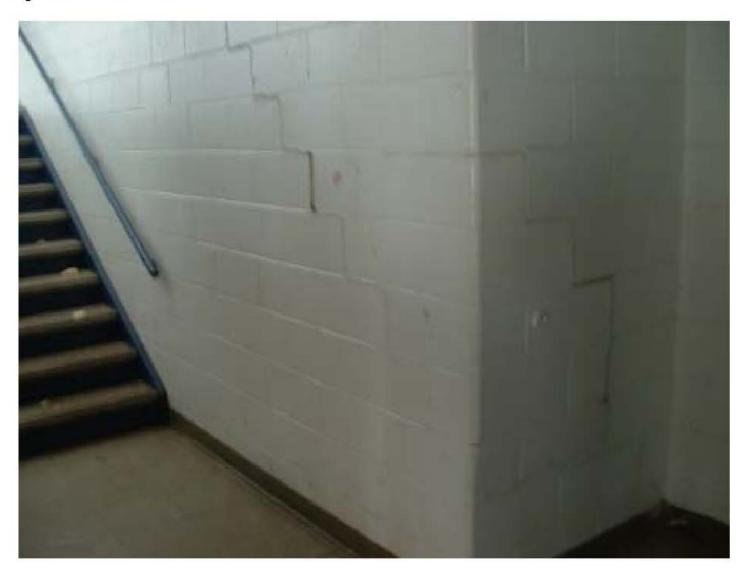
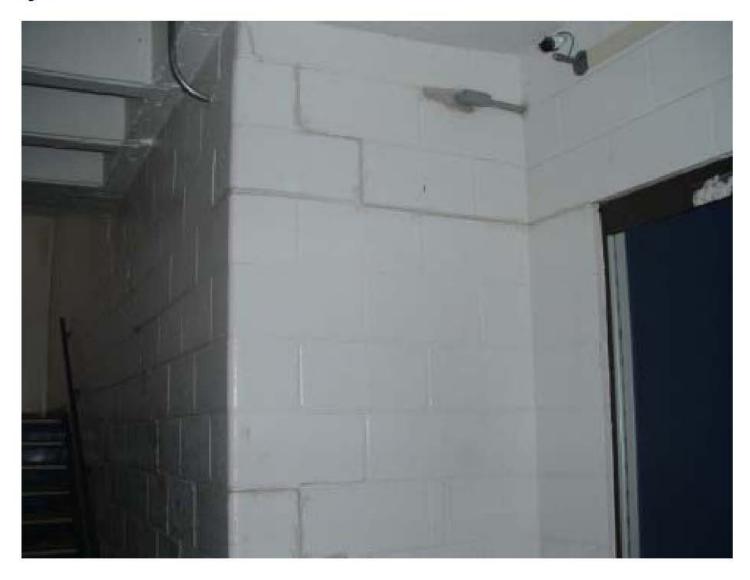
- Photographs # 51, # 52, and # 53 show cracks in the Left stair tower Ground Level walls. These cracks have been previously caulked and painted. There are no new cracks in these walls.

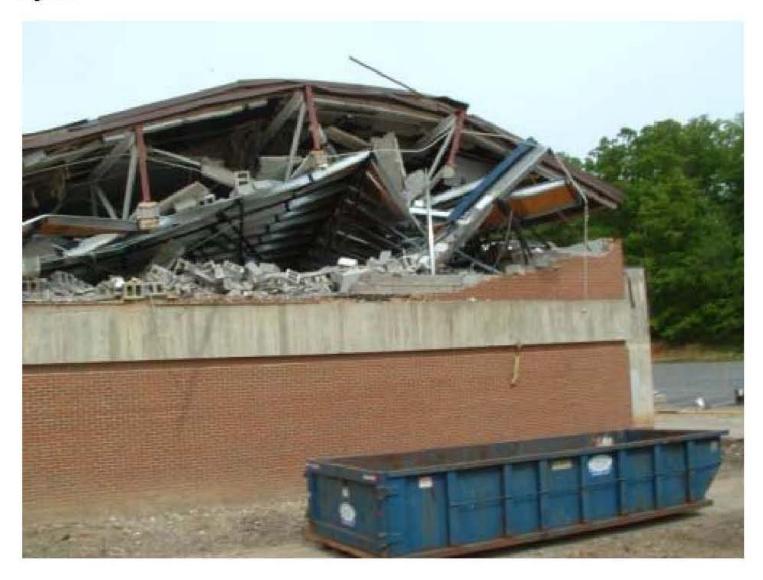
PHOTOGRAPH # 54 DATE TAKEN: 5/10/2010 FORCON #V10155

- Photographs # 54, # 55, and # 56 show the left side of the building before demolition.
  - There is an existing crack monitor located in the Girl's Locker Room (Photograph # 57), on the opposite side of the wall from Photographs # 51, # 52, and # 53. Photograph # 58 shows permanent shoring installed previously to support the Gymnasium floor above.

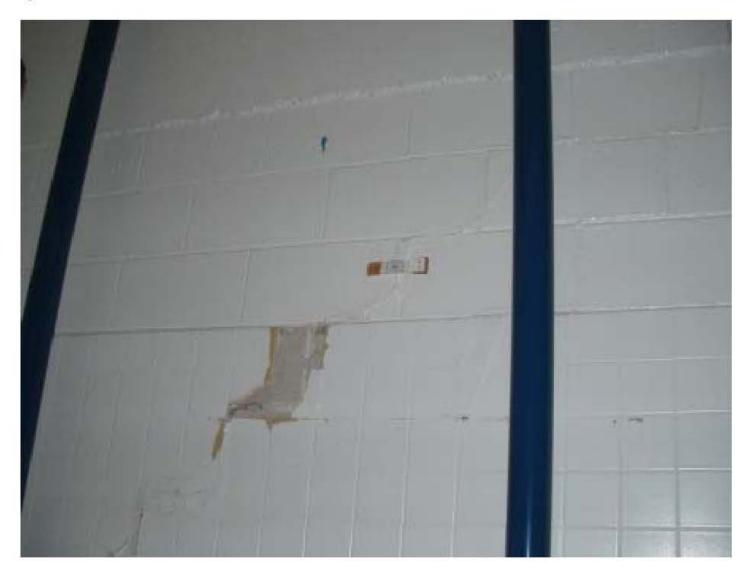
PHOTOGRAPH # 57 DATE TAKEN: 5/10/2010 FORCON #V10155

OF SUBJECT: View of Existing crack monitor in Girl's Locker Room on Ground Level

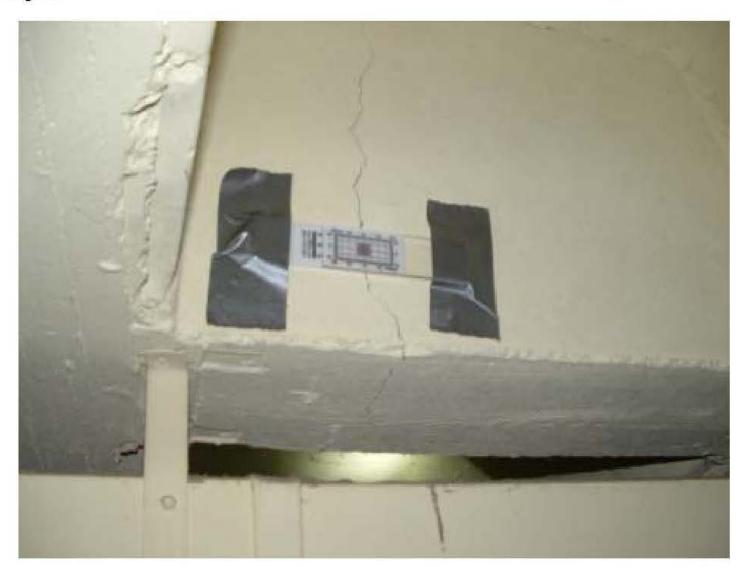
PHOTOGRAPH # 59 DATE TAKEN: 5/10/2010 FORCON #V10155

- To monitor additional movements of the Gymnasium floor and supporting walls during demolition, seven crack monitors were installed at various locations across existing cracks in Gymnasium floor concrete beams and joists, as well as cracks in the existing CMU walls (Photograph # 59).

OF SUBJECT: View of Crack Monitor Gymnasium Floor Concrete Beam

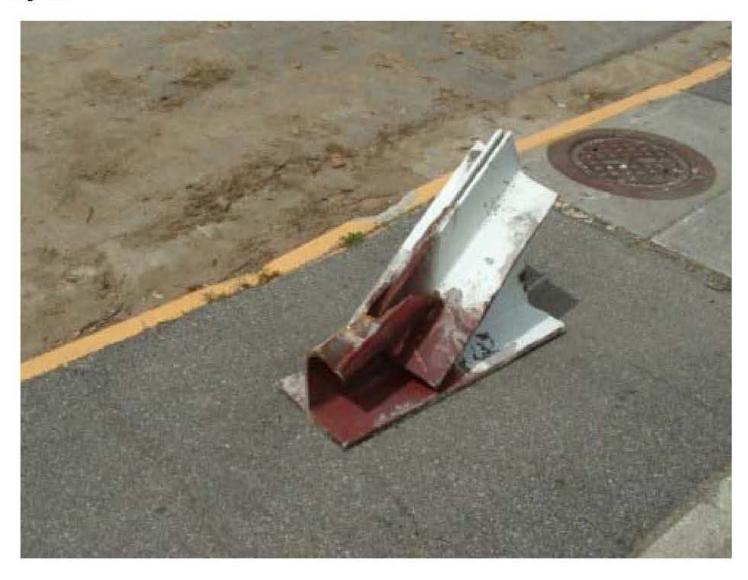
PHOTOGRAPH # 60 DATE TAKEN: 5/10/2010 FORCON #V10155

- Photographs # 60 and # 61 show the South end of the West main truss. This is to be transported to a metallurgical laboratory.
  - Photograph # 62 shows the Southwest column as well as the South end of the West main roof truss.

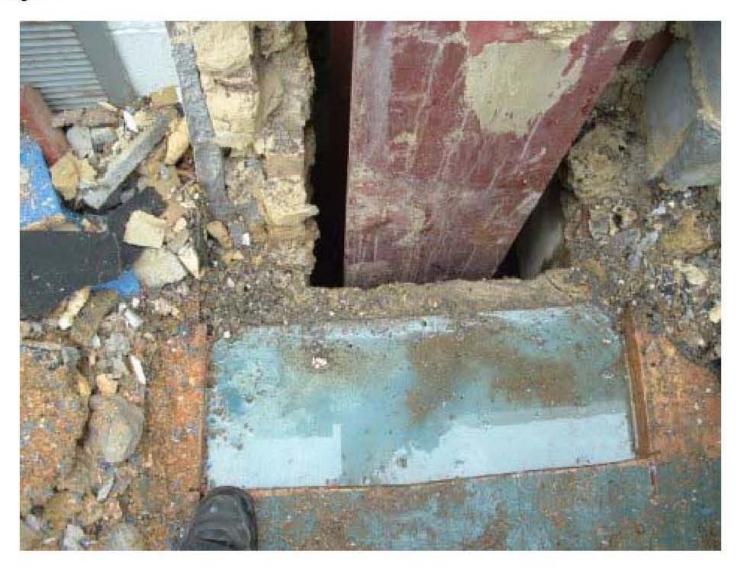
PHOTOGRAPH # 63 DATE TAKEN: 5/10/2010 FORCON #V10155

- Photograph # 63 shows the Gymnasium Floor opening at the Southwest columnthere is no apparent damage to the concrete.
  - Photographs # 64 and # 65 show the North end of the west main truss at the Northwest column. The truss is jammed into the existing column and held 4 feet above the Gymnasium Floor.

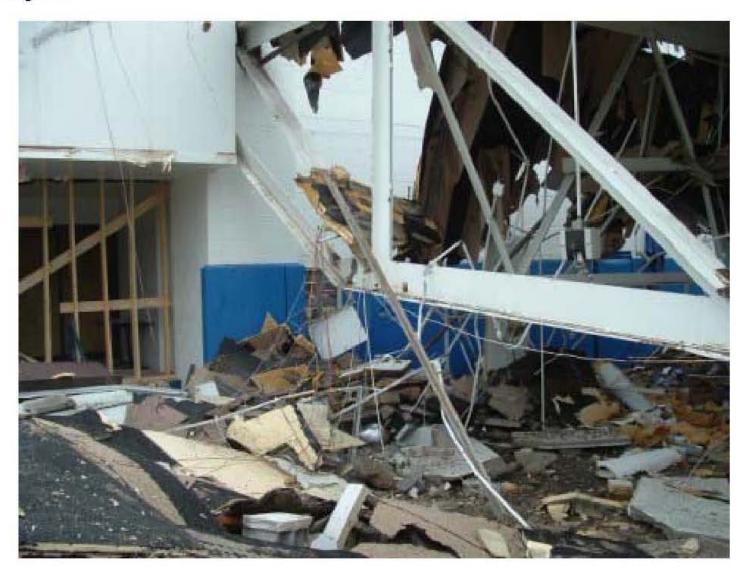
PHOTOGRAPH # 65 DATE TAKEN: 5/10/2010 FORCON #V10155

COMMENTS: Note truss bottom chord is suspended above floor.

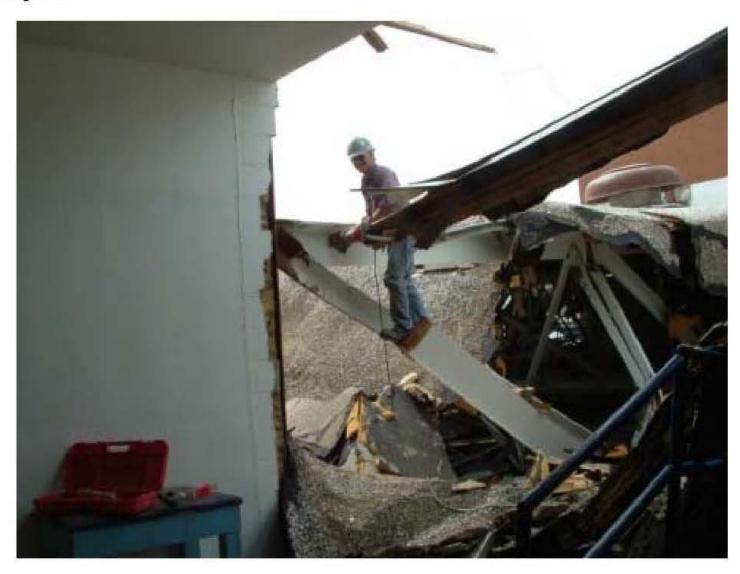
PHOTOGRAPH # 66 DATE TAKEN: 5/10/2010 FORCON #V10155

- Photograph # 66 shows the south end of the East main truss being cut off. Photographs # 67 and # 68 show the truss after the end has been cut off.
  - Photograph # 69 shows the Gymnasium Floor opening at the Southeast columnthere is no apparent damage to the concrete.

COMMENTS: Note truss bottom chord is suspended above floor.

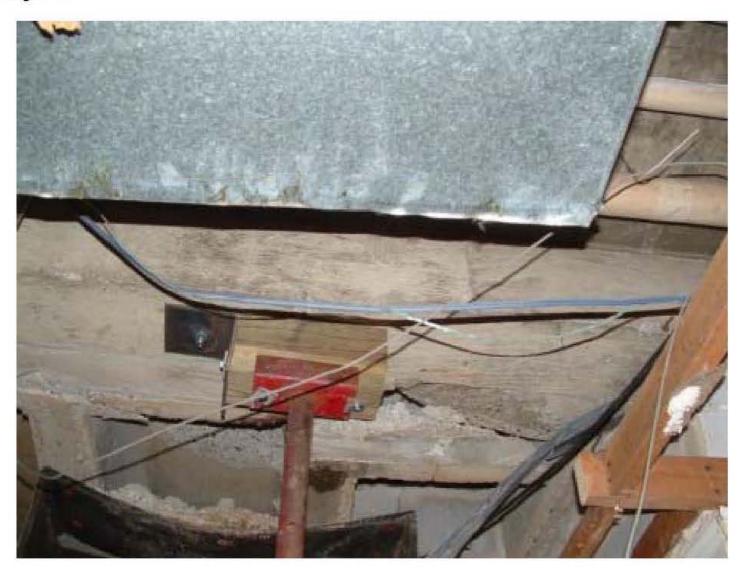
PHOTOGRAPH # 70 DATE TAKEN: 5/10/2010 FORCON #V10155

- Photographs # 70 and # 71 show the shoring installed below the Gymnasium Floor framing near the Southeast column. The floor joist has broken away from the concrete turndown beam that spans between the CMU load-bearing walls. A crack monitor was installed on the beam at this location.

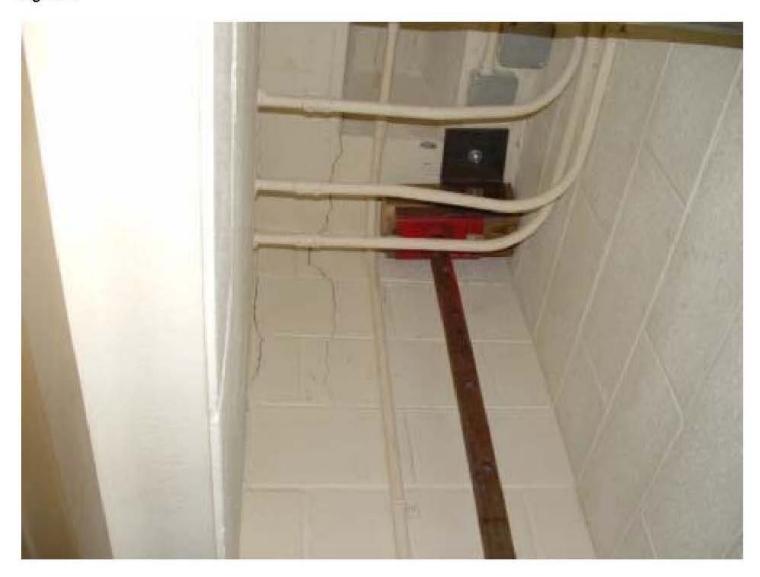
PHOTOGRAPH # 72 DATE TAKEN: 5/10/2010 FORCON #V10155

- Photograph # 72 shows shoring installed beneath a cracked concrete beam in Electrical Distribution Room A-47 located on the East side of the East Corridor.
     Beyond the cracked CMU wall shown, the structural system changes from a concrete pan-joist system to a one-way slab spanning between concrete beams.

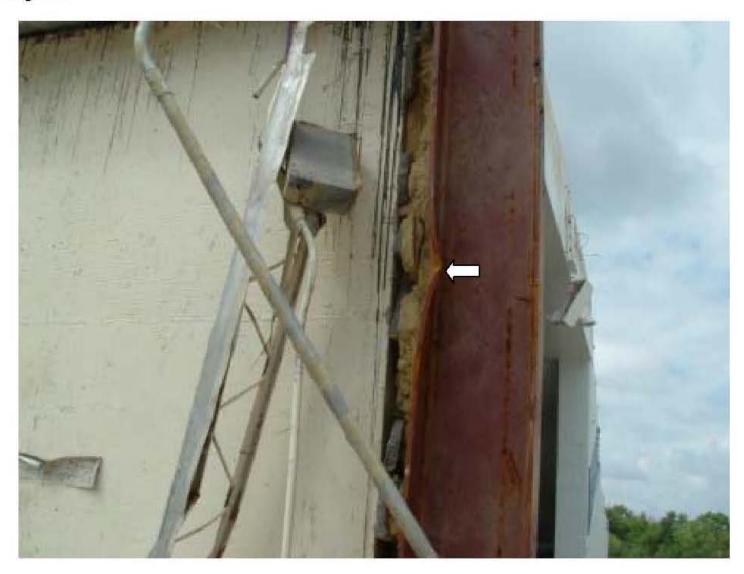
PHOTOGRAPH # 74 DATE TAKEN: 5/19/2010 FORCON #V10155

COMMENTS: White arrow denotes impact point.

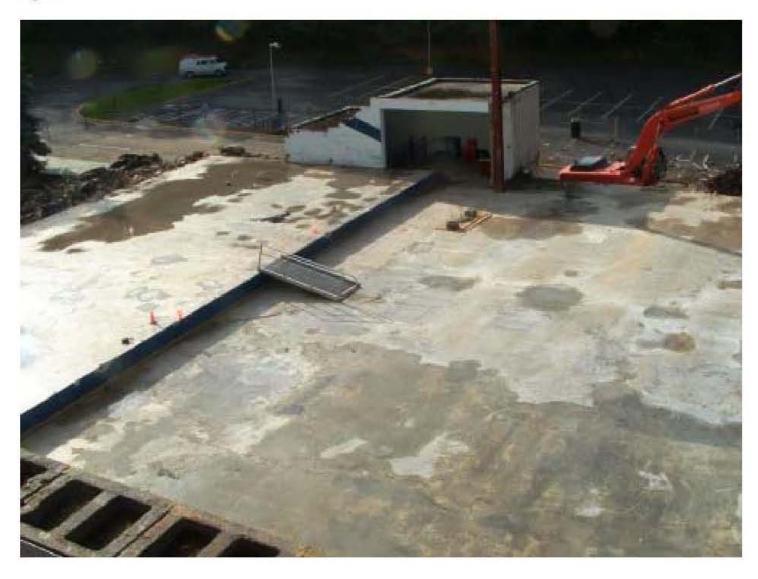
PHOTOGRAPH # 75 DATE TAKEN: 5/19/2010 FORCON #V10155

- Photographs # 75 and # 76 show an overall view of the Gymnasium Floor as seen from the rear (North). At the right and left sides (for the bleachers) the floor steps up two feet above the Gymnasium Floor level.

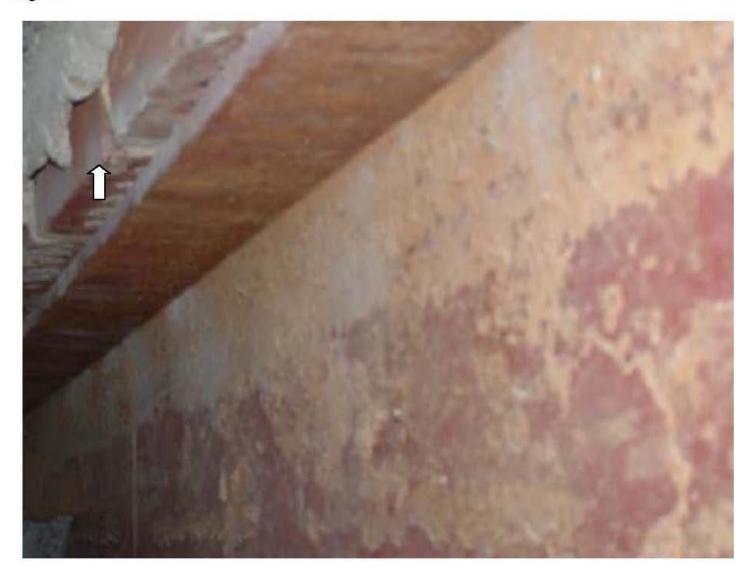
PHOTOGRAPH # 78 DATE TAKEN: 5/19/2010 FORCON #V10155

- Photograph # 77 shows the Northwest column bent outward with steel beam attached at the mezzanine roof level, shifting the beam outward. See Photograph # 78. Photograph # 79 shows water damage to the press box roof. Photograph # 80 shows the press box area with walls and roof removed.

COMMENTS: White arrow denotes masonry left unsupported when beam moved.

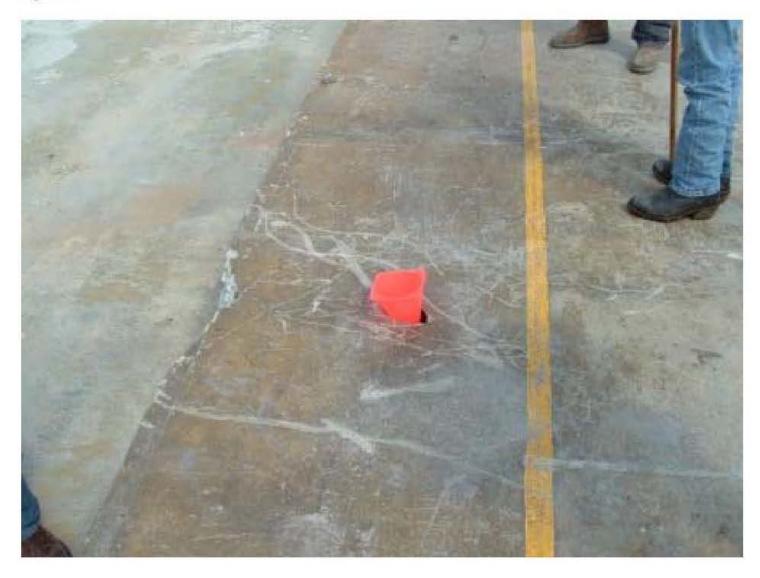
PHOTOGRAPH # 82 DATE TAKEN: 5/19/2010 FORCON #V10155

- Photograph # 82 shows a six inch diameter hole through the right, raised area 20 feet from the front edge. Photograph # 83 shows this hole is punched through the slab, between the concrete joists.

COMMENTS: Orange cone is inverted in the hole.

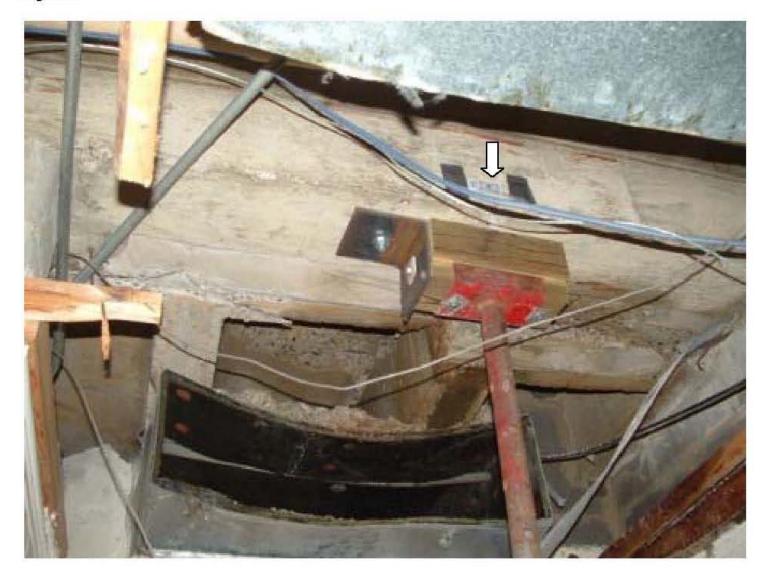
PHOTOGRAPH # 86 DATE TAKEN: 5/19/2010 FORCON #V10155

- Photograph # 84 shows the hole that was punched through the slab and joists by the bottom chord and vertical web of the East main truss (directly below Photographs # 42 and # 43). Photograph # 85 shows the joist broken away from the concrete turndown beam- there is no reinforcement visible in the turndown beam. Photograph # 86 shows the underside of this area- there has been no movement in the crack monitor.

COMMENTS: Viewed from Ground Floor Level. White arrow denotes crack monitor.

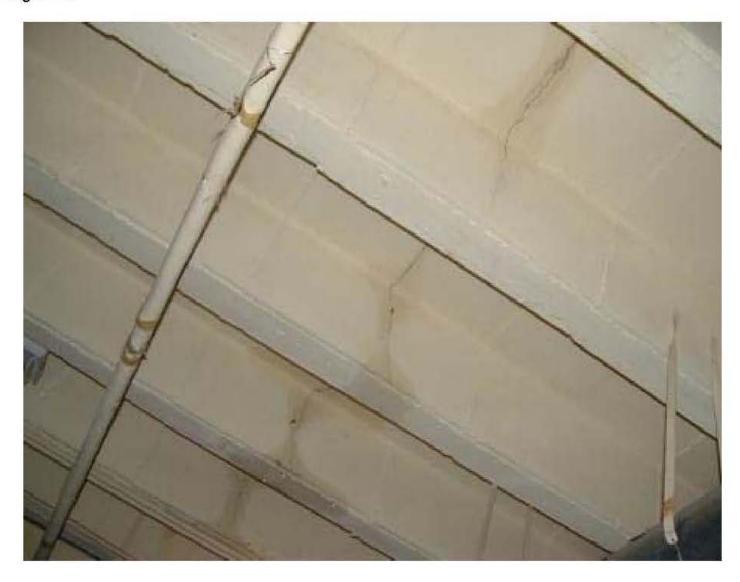
PHOTOGRAPH # 92 DATE TAKEN: 5/19/2010 FORCON #V 10155

- On the left raised area, there are two hairline cracks in the slab that extend from the left to the right sides, located approximately 35 and 70 feet from the front of the building. Photographs # 89, # 90, and # 91 show the crack located at 35 feet, viewed from the underside (Ground Level Ceiling) - the crack extends through the joists, with no reinforcement visible. Photographs # 92 and # 93 show the crack located at 70 feet.

COMMENTS: Viewed from Ground Floor Level.

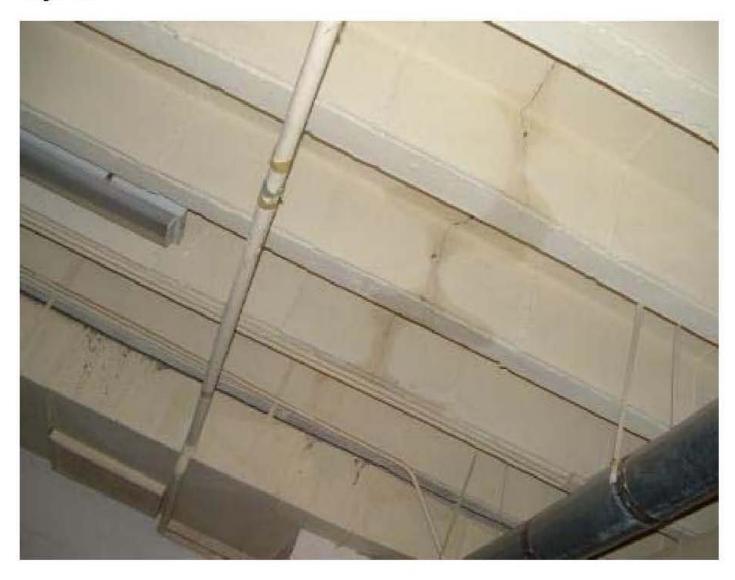
PHOTOGRAPH # 93 DATE TAKEN: 5/19/2010 FORCON #V10155

COMMENTS: Viewed from Ground Floor Level.

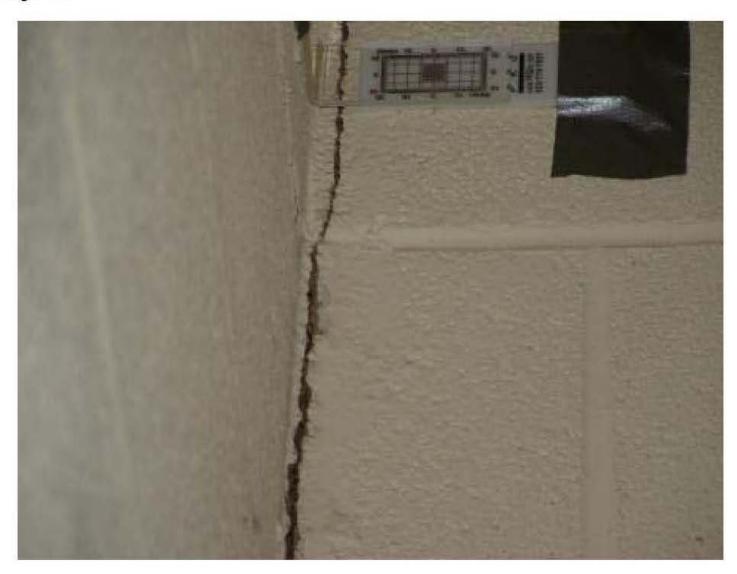
PHOTOGRAPH # 94 DATE TAKEN: 5/19/2010 FORCON #V 10155

- Photograph #94 shows a crack monitor installed over a vertical CMU crack where a partition intersects the wall at the left side of the West Corridor. There has been no movement.

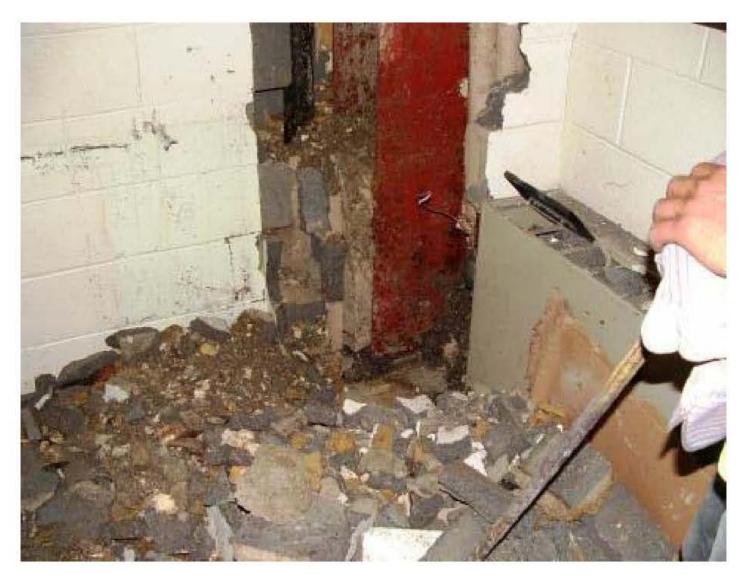
PHOTOGRAPH # 97 DATE TAKEN: 5/19/2010

- On the Ground Floor Level, the masonry pilaster surrounding the Southwest column base was removed. Photograph # 97 shows the concrete slab at the column- there were no visible cracks.
- On the Ground Floor Level, the masonry pilaster surrounding the Southeast column base was removed. Photograph # 98 shows the concrete slab at the column- there were no visible cracks.
