# **FORCON Report**

RE: Structural Investigation- Roof Collapse

Blacksburg High School Gymnasium

CLAIM #: DMF3428 FORCON CASE #: V10155

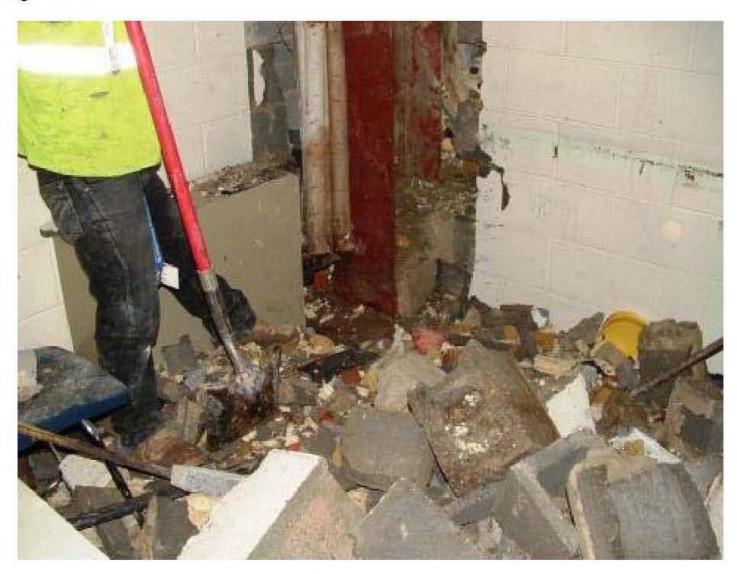
PHOTOGRAPH # 98 DATE TAKEN: 5/19/2010 FORCON #V 10155

- On the Ground Floor Level, the masonry pilaster surrounding the Southwest column base was removed. Photograph # 97 shows the concrete slab at the column- there were no visible cracks.
- On the Ground Floor Level, the masonry pilaster surrounding the Southeast column base was removed. Photograph # 98 shows the concrete slab at the column- there were no visible cracks.
