Montgomery County Public Schools

Blacksburg High School

Facility Assessment

OWPR, Inc. June 7, 2010

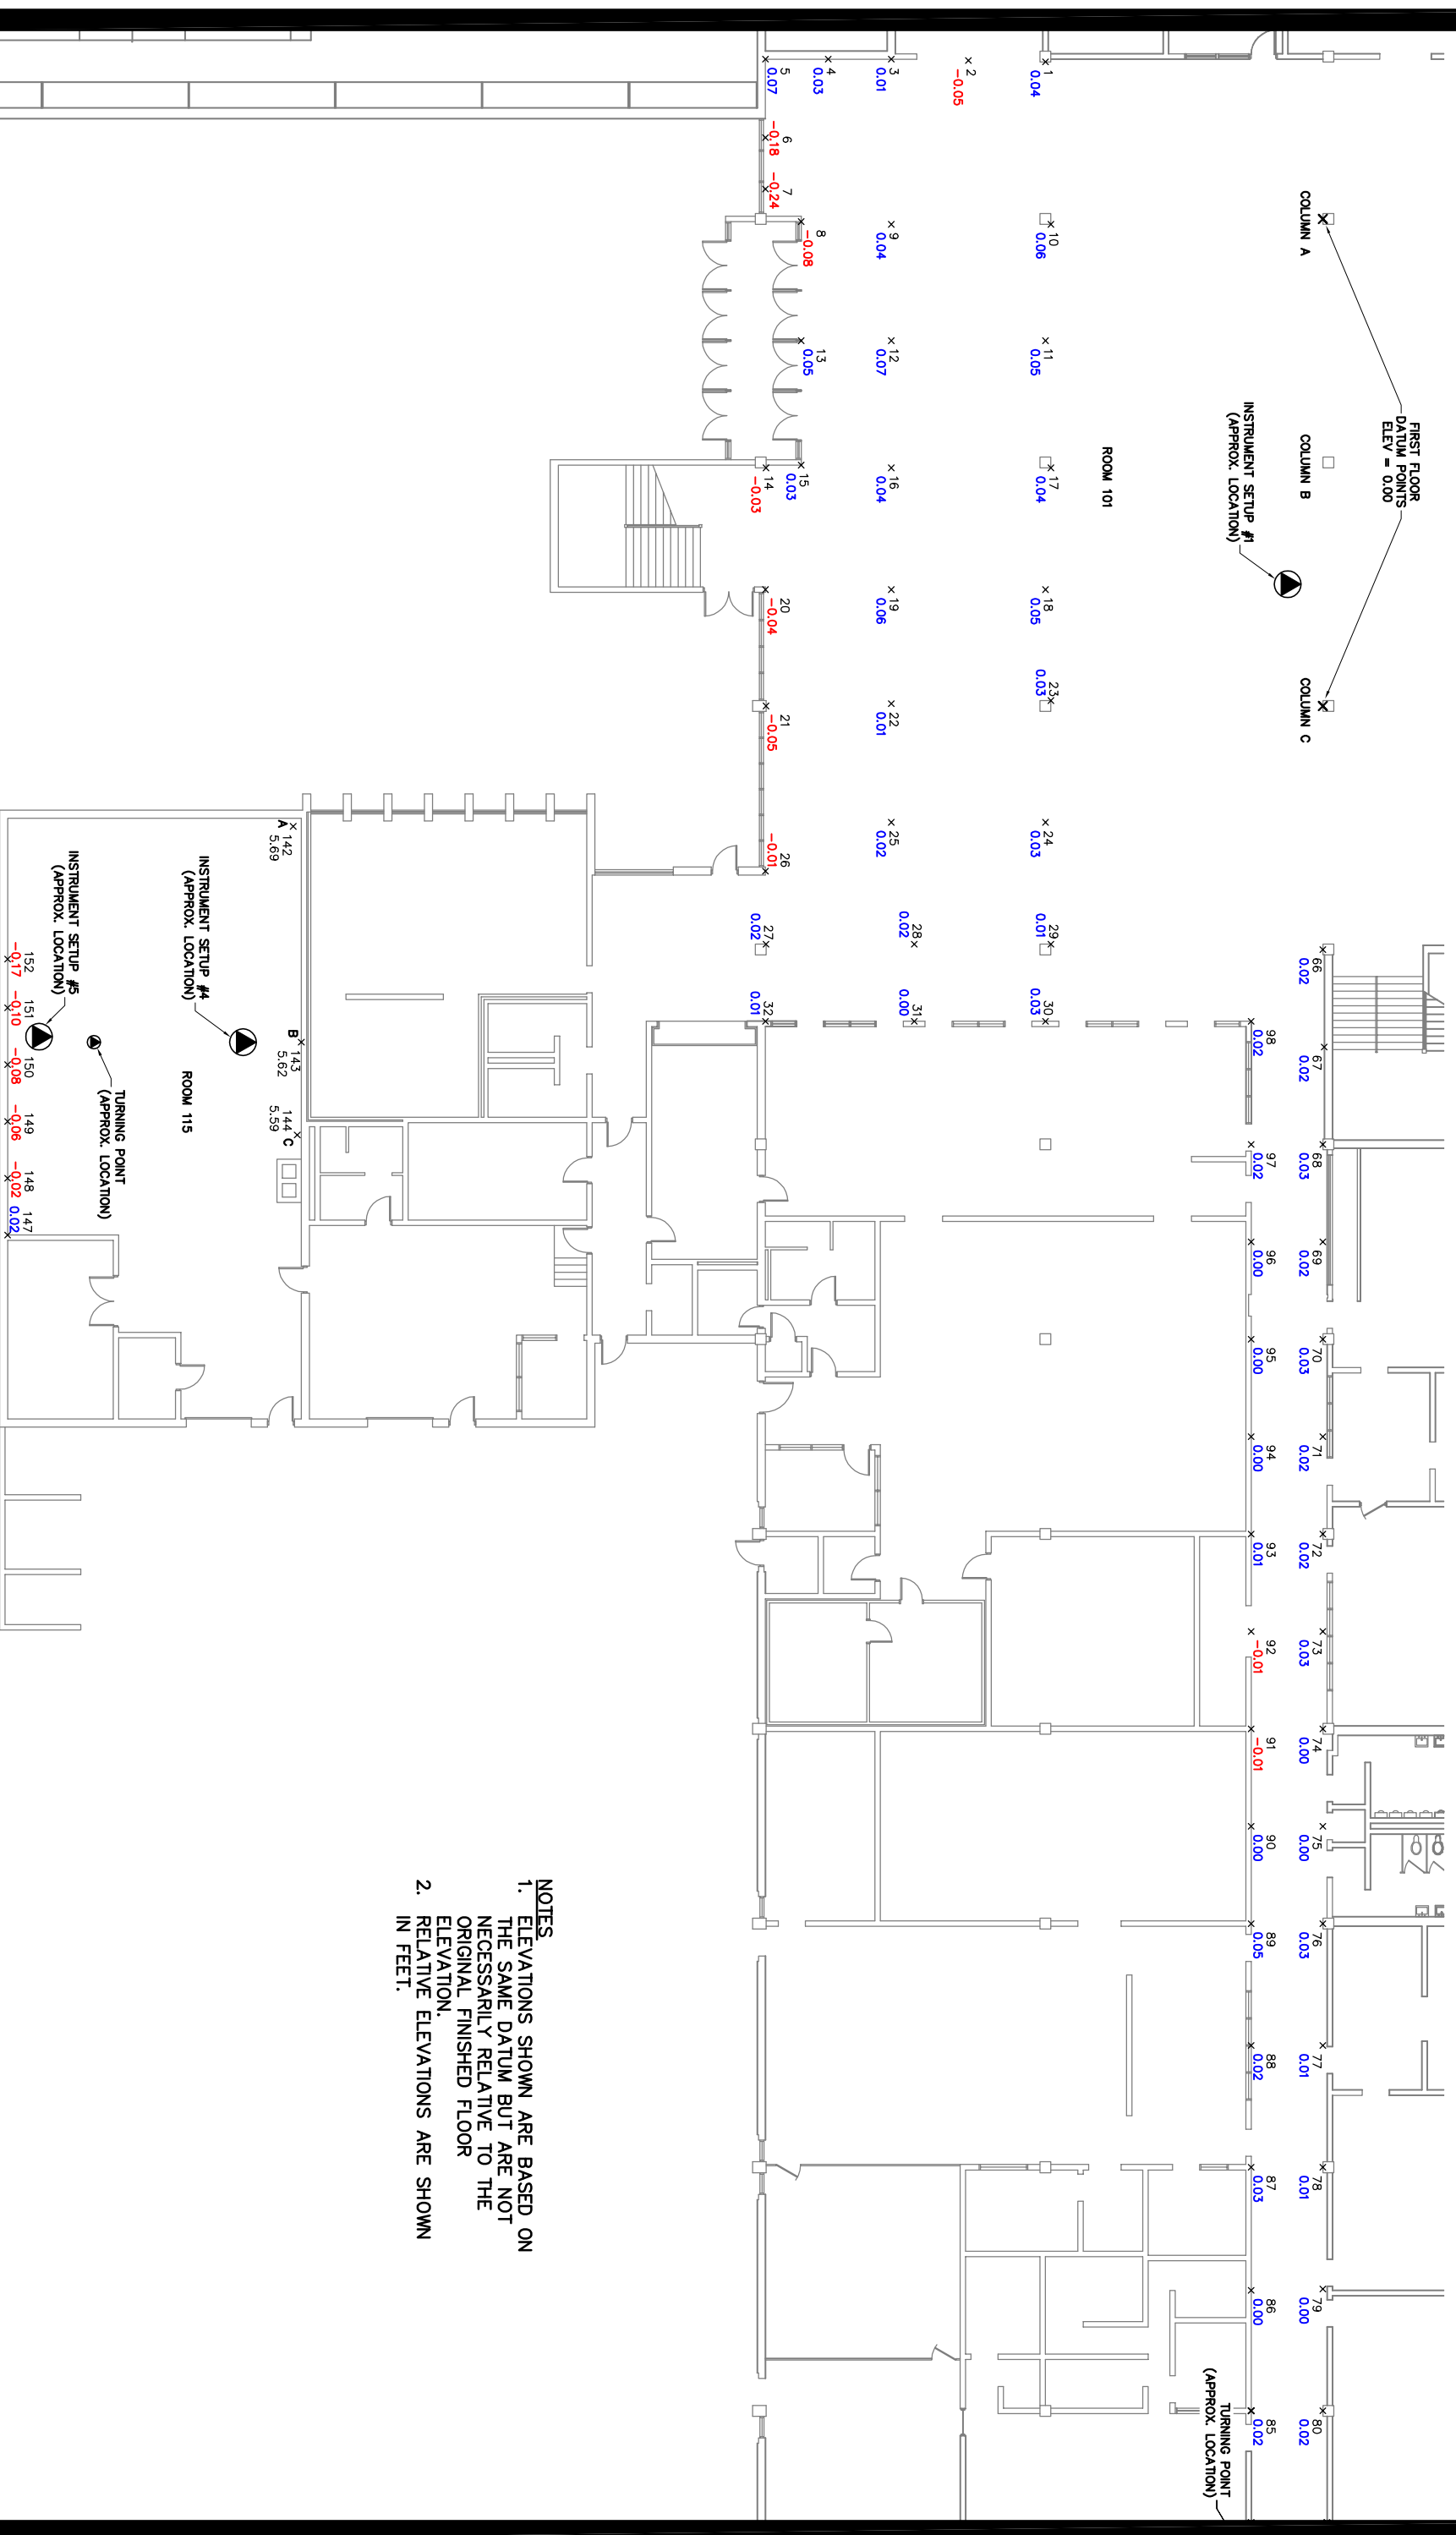
FIRST FLOOR, PLAN B

- NOTES**
1. ELEVATIONS SHOWN ARE BASED ON THE SAME DATUM BUT ARE NOT NECESSARILY RELATIVE TO THE ORIGINAL FINISHED FLOOR ELEVATION.
 2. RELATIVE ELEVATIONS ARE SHOWN IN FEET.

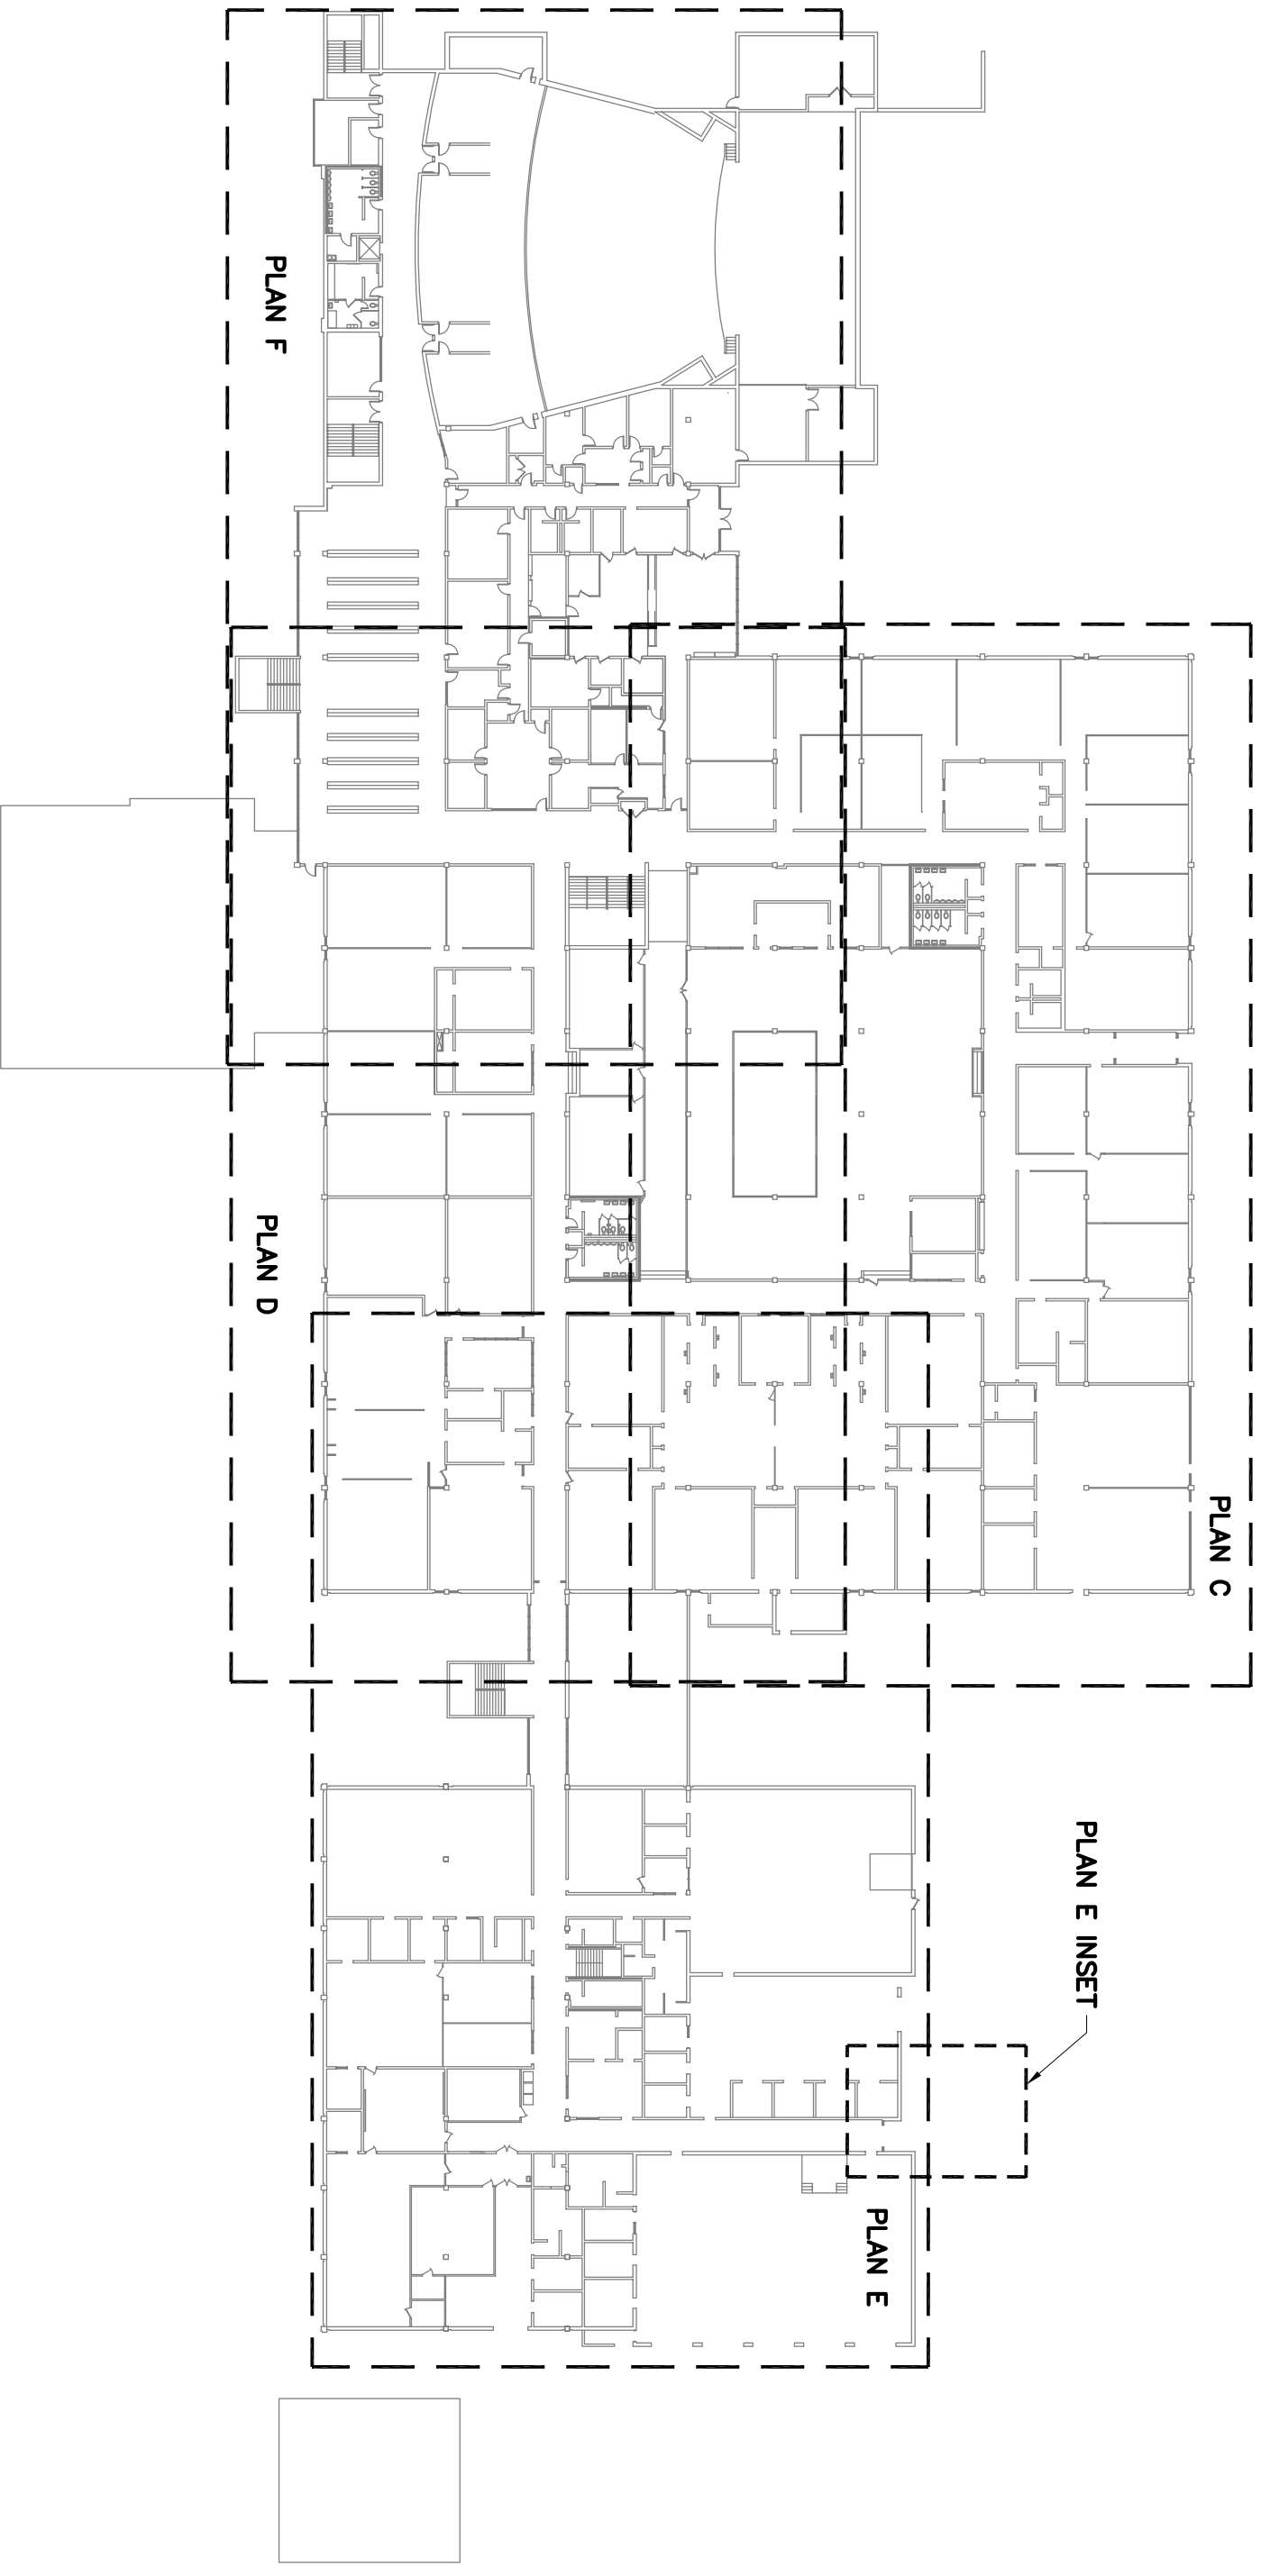
SECOND FLOOR, PLAN C

- NOTES**
1. ELEVATIONS SHOWN ARE BASED ON THE SAME DATUM BUT ARE NOT NECESSARILY RELATIVE TO THE ORIGINAL FINISHED FLOOR ELEVATION.
 2. RELATIVE ELEVATIONS ARE SHOWN IN FEET.

REFERENCE POINT: RIGHT FRONT CORNER OF BOTTOM STEP IN STAIRS

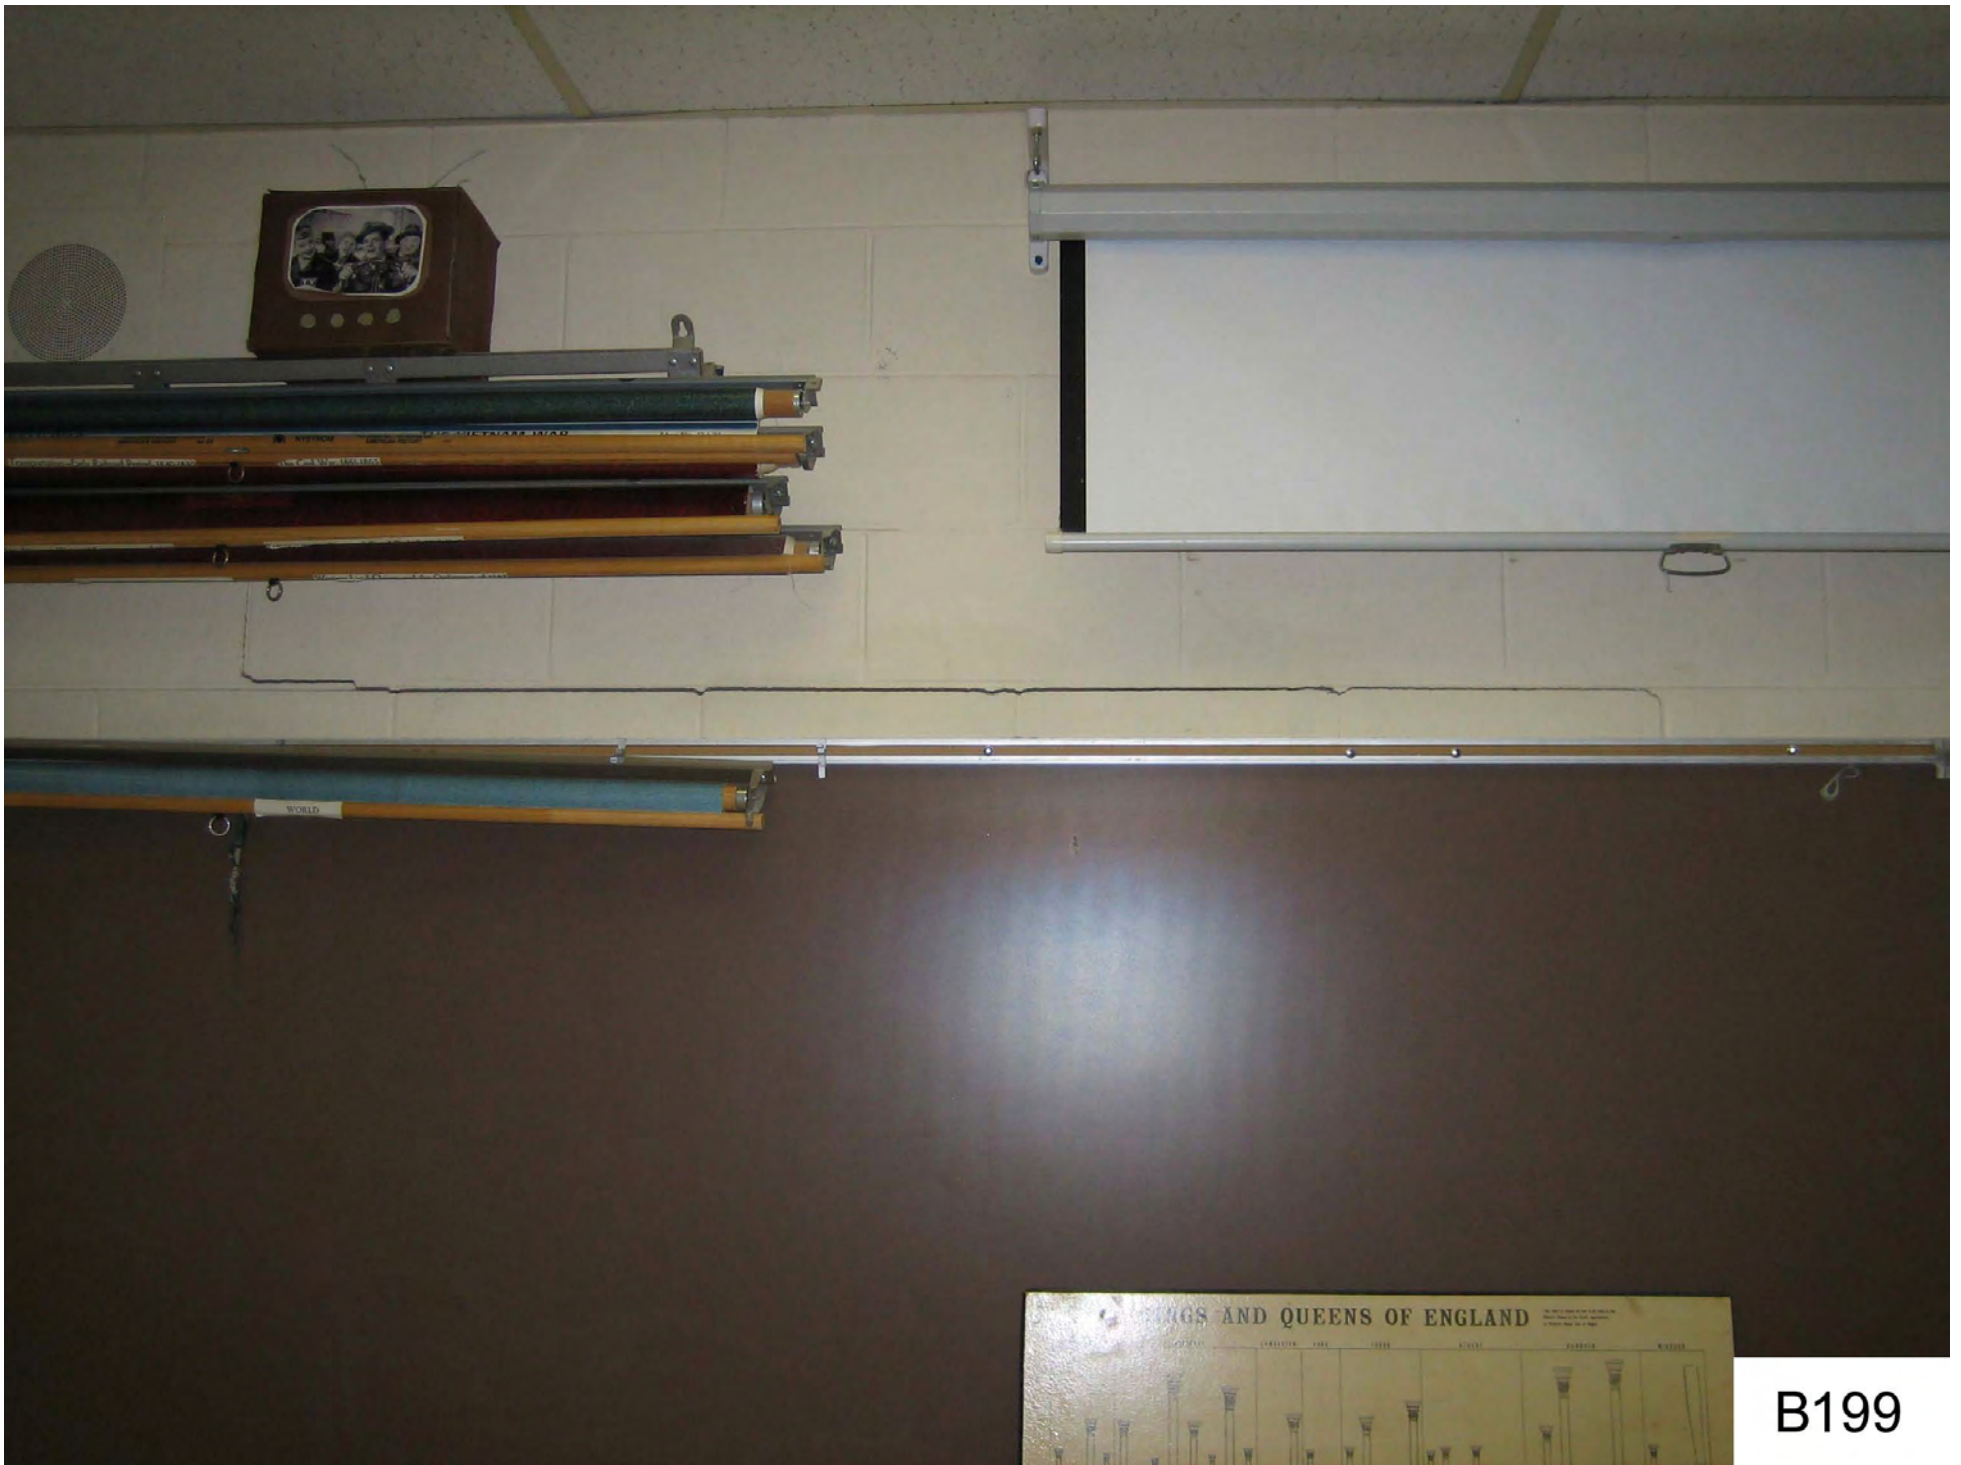
408	B198	crack in CMU wall	building movement	2
406	B199	crack in CMU wall, horiz.	building movement	2
406	B200	crack in CMU wall	building movement	2
405	B201	crack in CMU wall	building movement	4
405	B202	crack in CMU wall	building movement	3
410	B203	crack in CMU wall	building movement	2
410	B204	crack in CMU wall	building movement	2
410	B205	crack in CMU wall	building movement	3
411	B206	crack in CMU wall	building movement	3

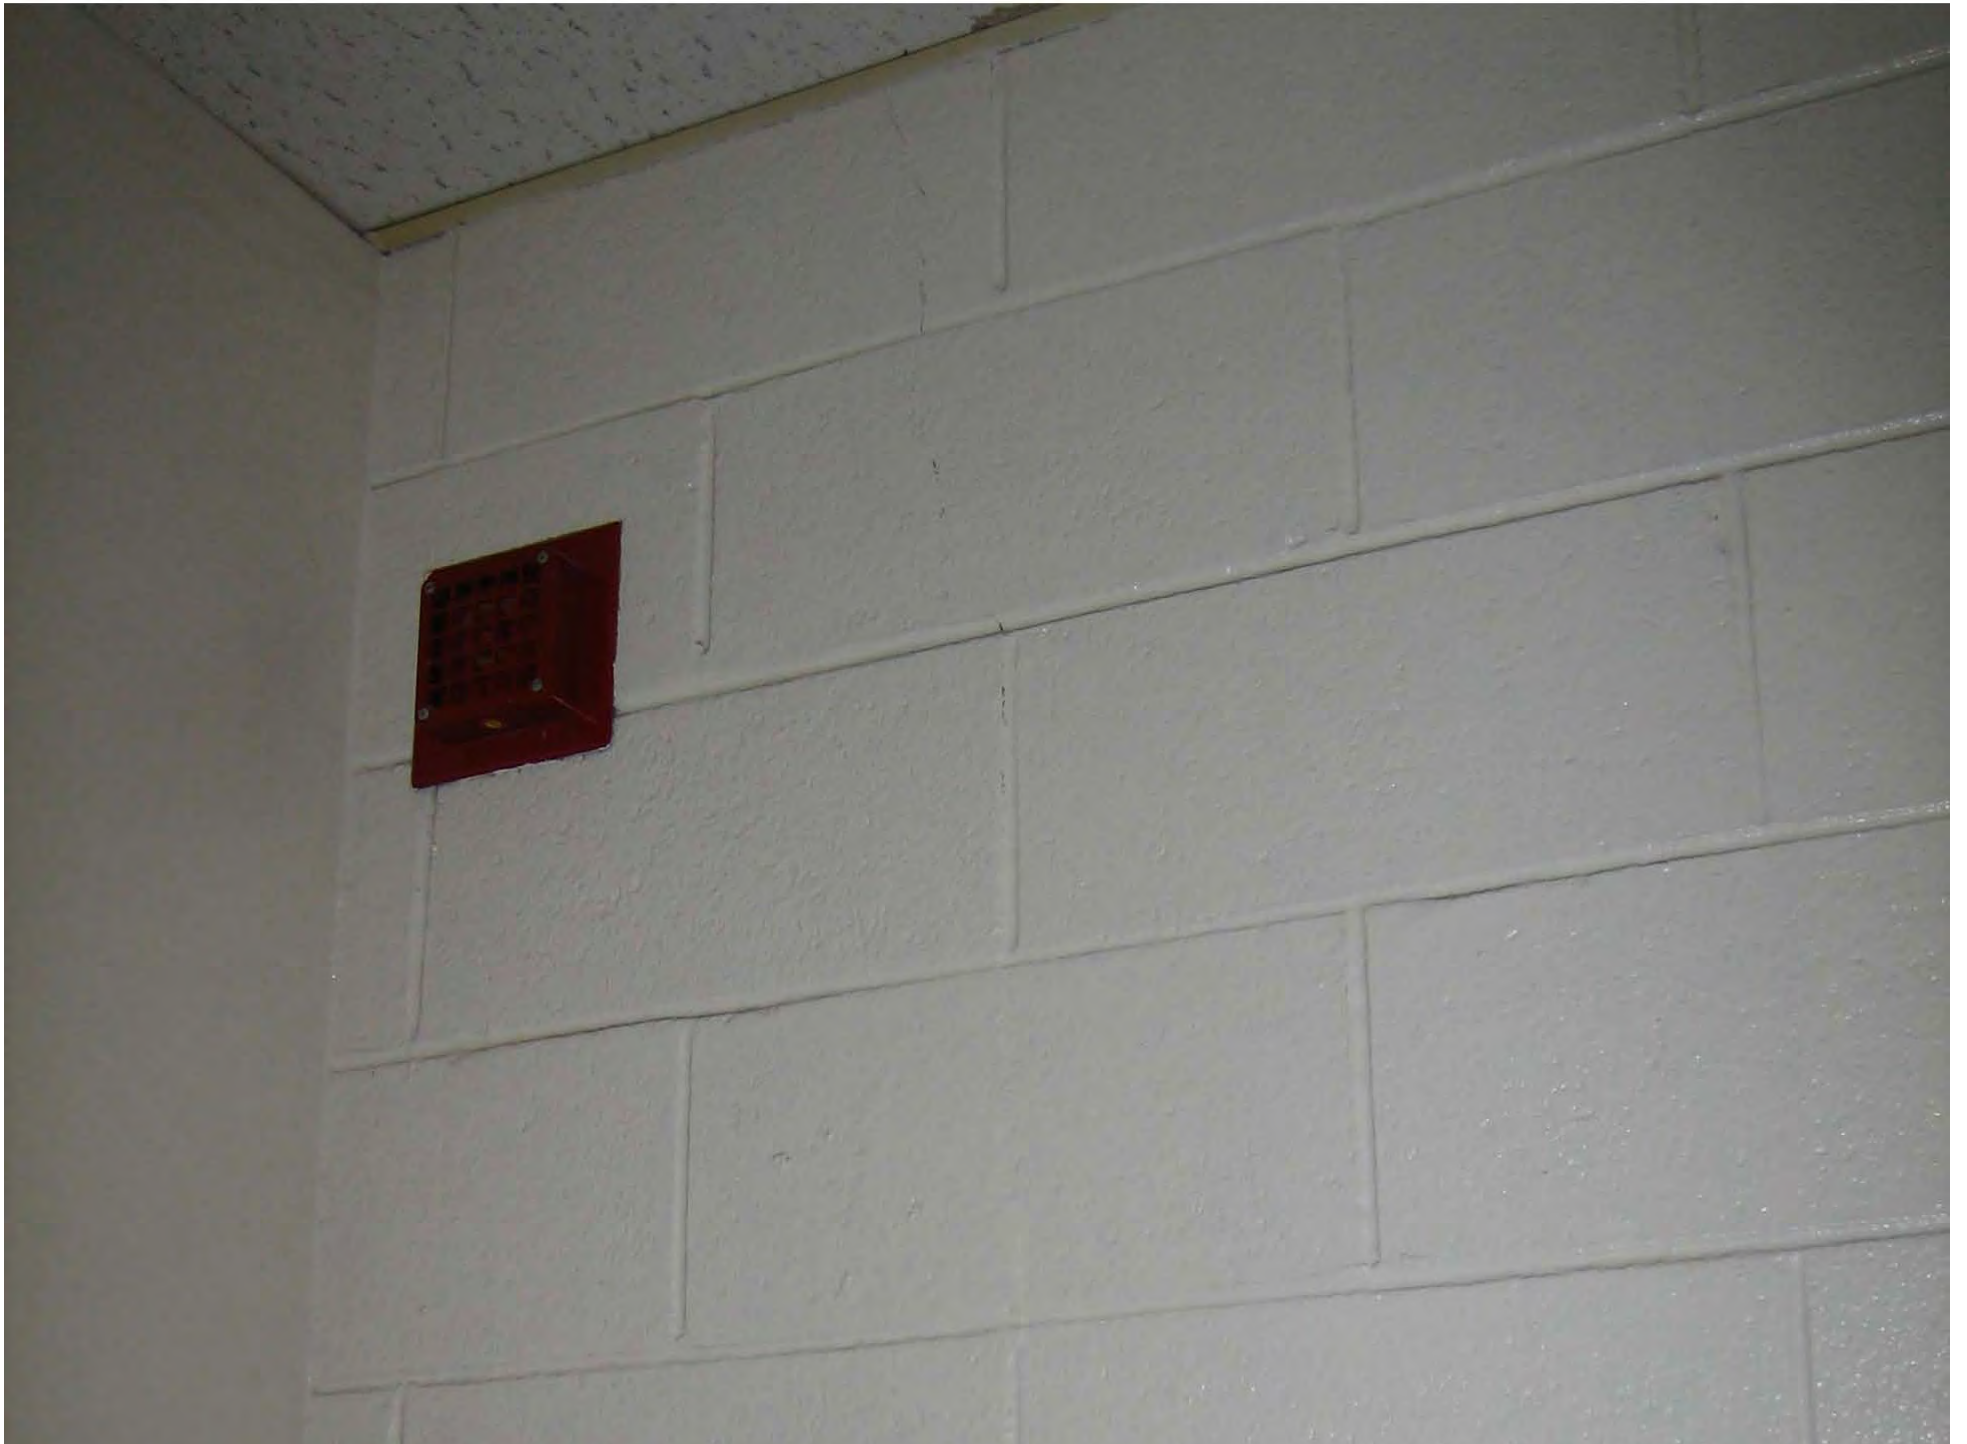
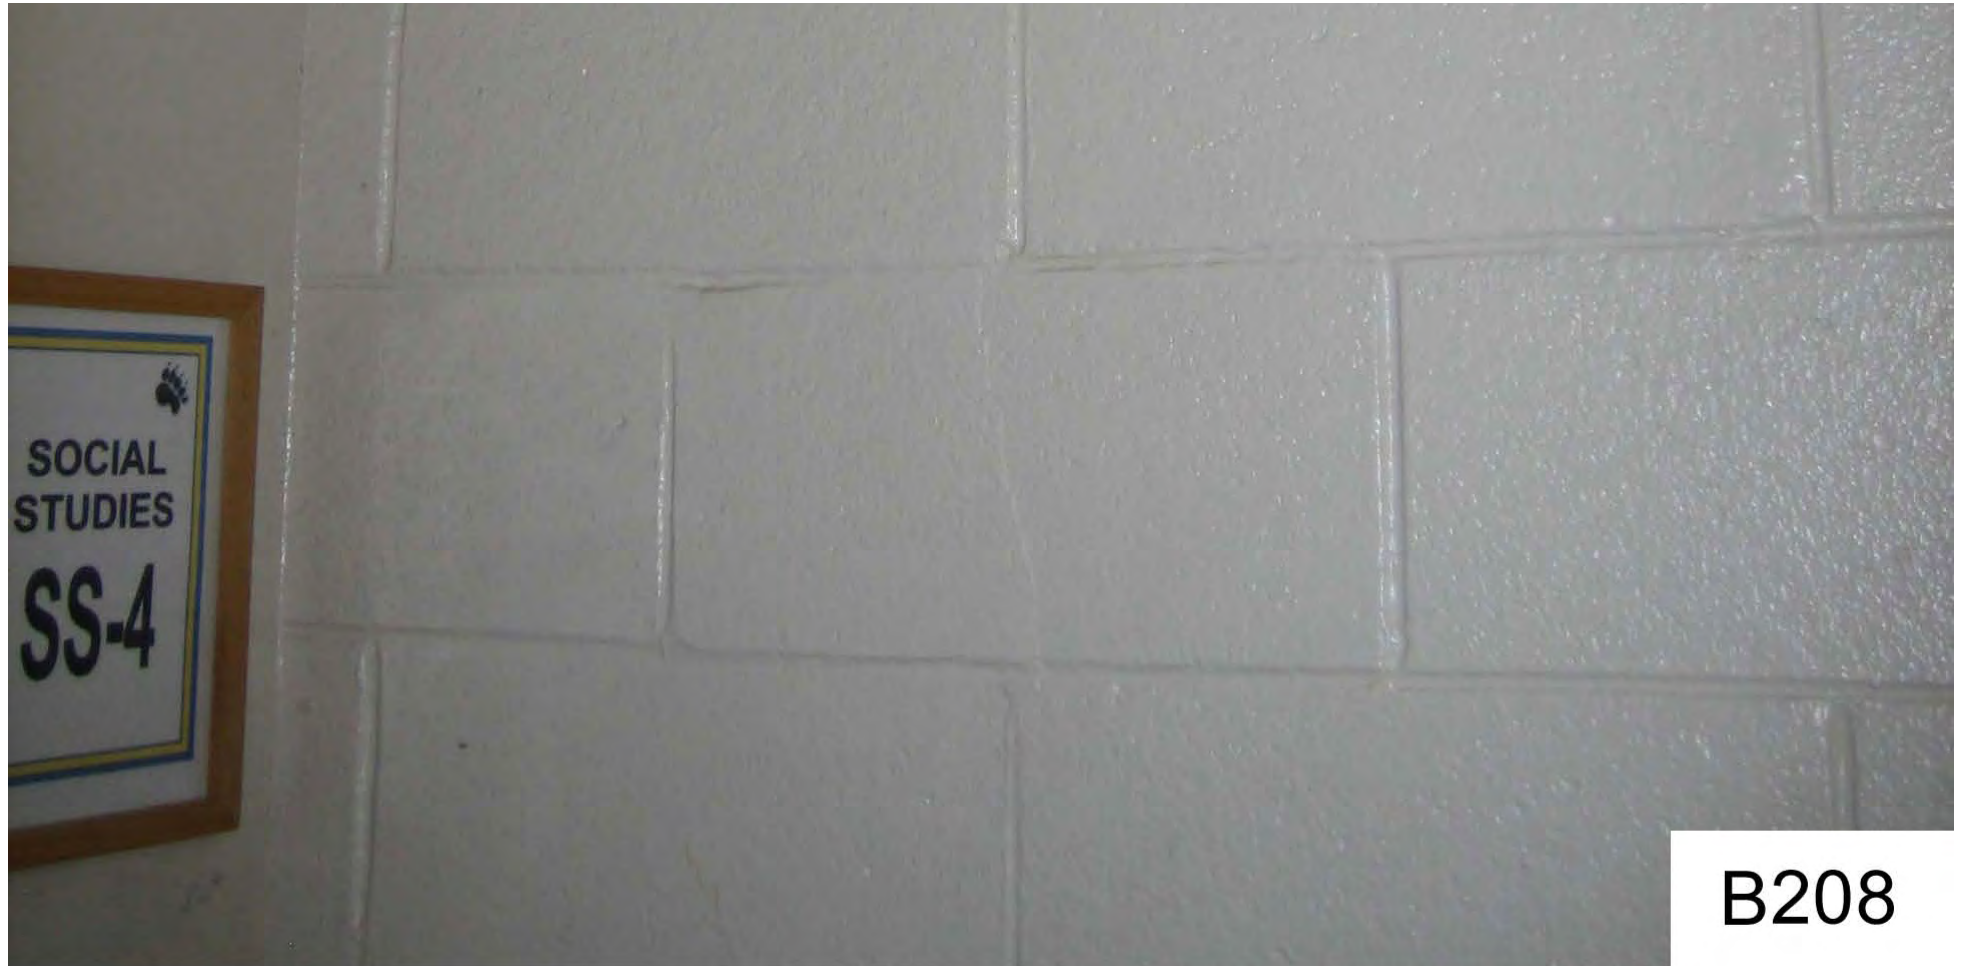
Space #	Photo/ Issue #	Issue Description	Possible Cause	Action
411	B207	crack in CMU wall, peeling paint	building movement	3
412	B208	crack in CMU wall, repaired	building movement	4
413	B209	crack in CMU wall	building movement	2
413	B210	crack in CMU wall	building movement	3
416	B211	crack in CMU wall	building movement	3
418	B212	crack in CMU wall, horiz.	building movement	2
419	B213	crack in CMU wall, horiz.	building movement	2
420	B214	crack in CMU wall, horiz.	building movement	2
421	B215	crack in CMU wall, horiz.	building movement	2
421	B216	crack in CMU wall, horiz.	building movement	2
422	B217	crack in CMU wall	building movement	3
422	B218	crack in CMU wall, horiz.	building movement	3
422	B219	crack in CMU wall & roof leak	building movement	2
423	B220	crack in CMU wall	building movement	4
424	B221	crack in CMU wall	building movement	4
425	B222	crack in CMU wall	building movement	2
425	B223	crack in CMU wall,corner	building movement	4
